Wetland Delineation Report.....1-6

Figure 2. Wetland/Waterway Boundary Map
 Southbrook Church
 City of Franklin
 Milwaukee County, WI

Figure 3
 NRCS Web Soil Survey Map
 Southbrook Church
 City of Franklin
 Milwaukee County, WI

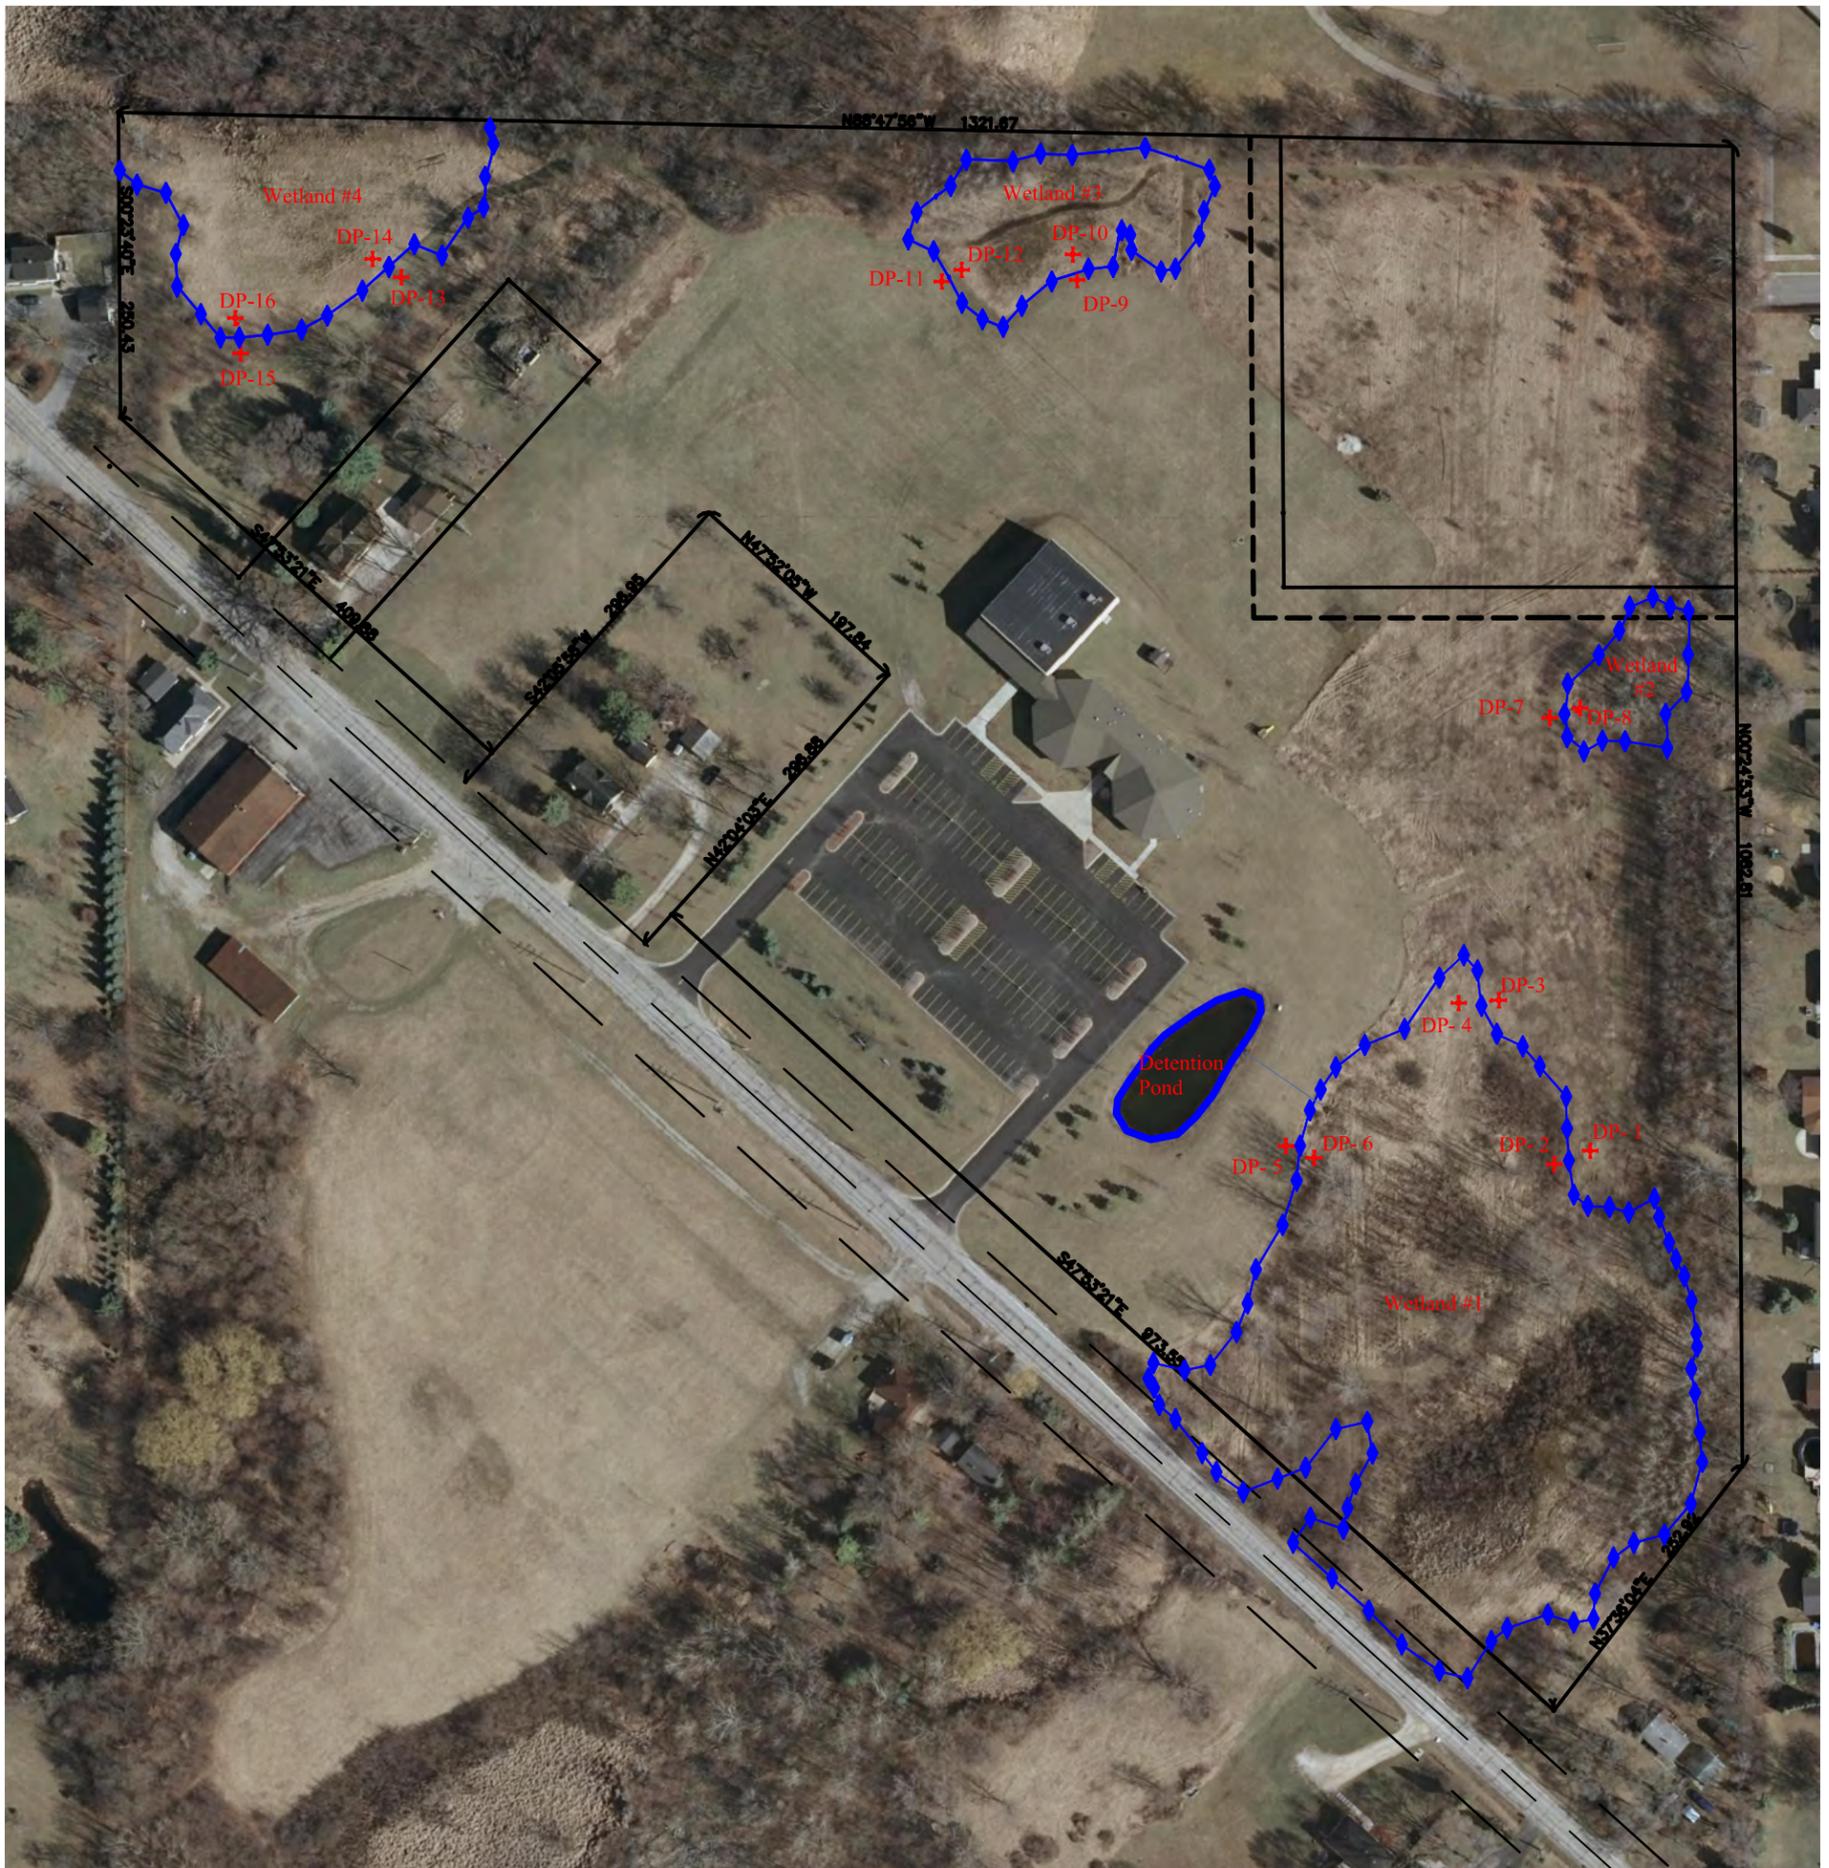
WETLAND BOUNDARY SURVEYED BY MC CLURE ENGINEERING
 2010 AERIAL PHOTO SOURCE: SOUTHEASTERN WISCONSIN REGIONAL PLANNING COMMISSION

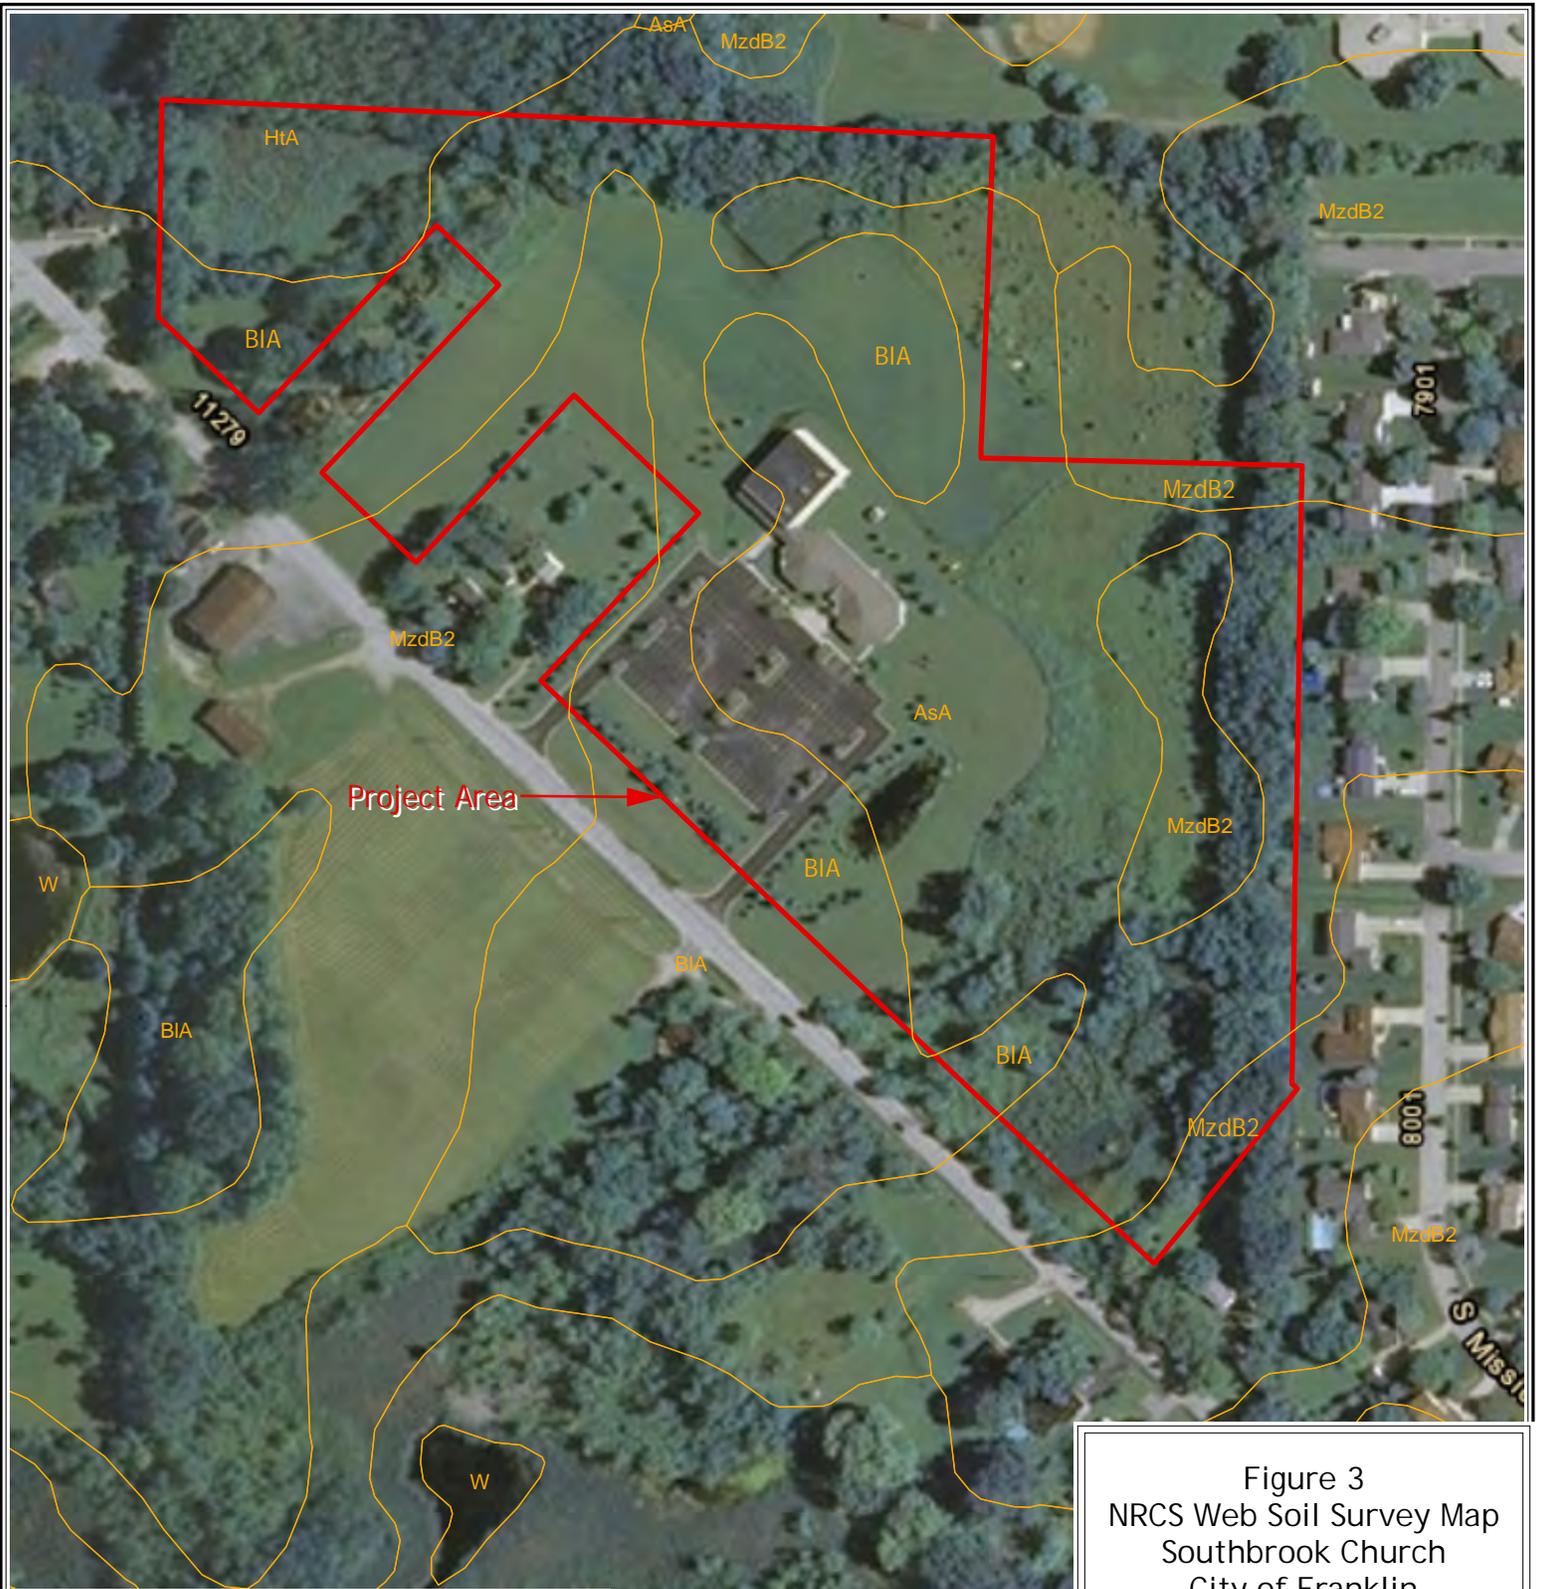
Legend	
Map Unit Symbol	Map Unit Name
AsA	Ashkum silty clay loam, 0 to 3 percent slopes (C)
BIA	Blount silt loam, 1 to 3 percent slopes(I)
HtA	Houghton muck, 0 to 2 percent slopes (C)
MzdB2	Morley silt loam, 2 to 6 percent slopes, eroded

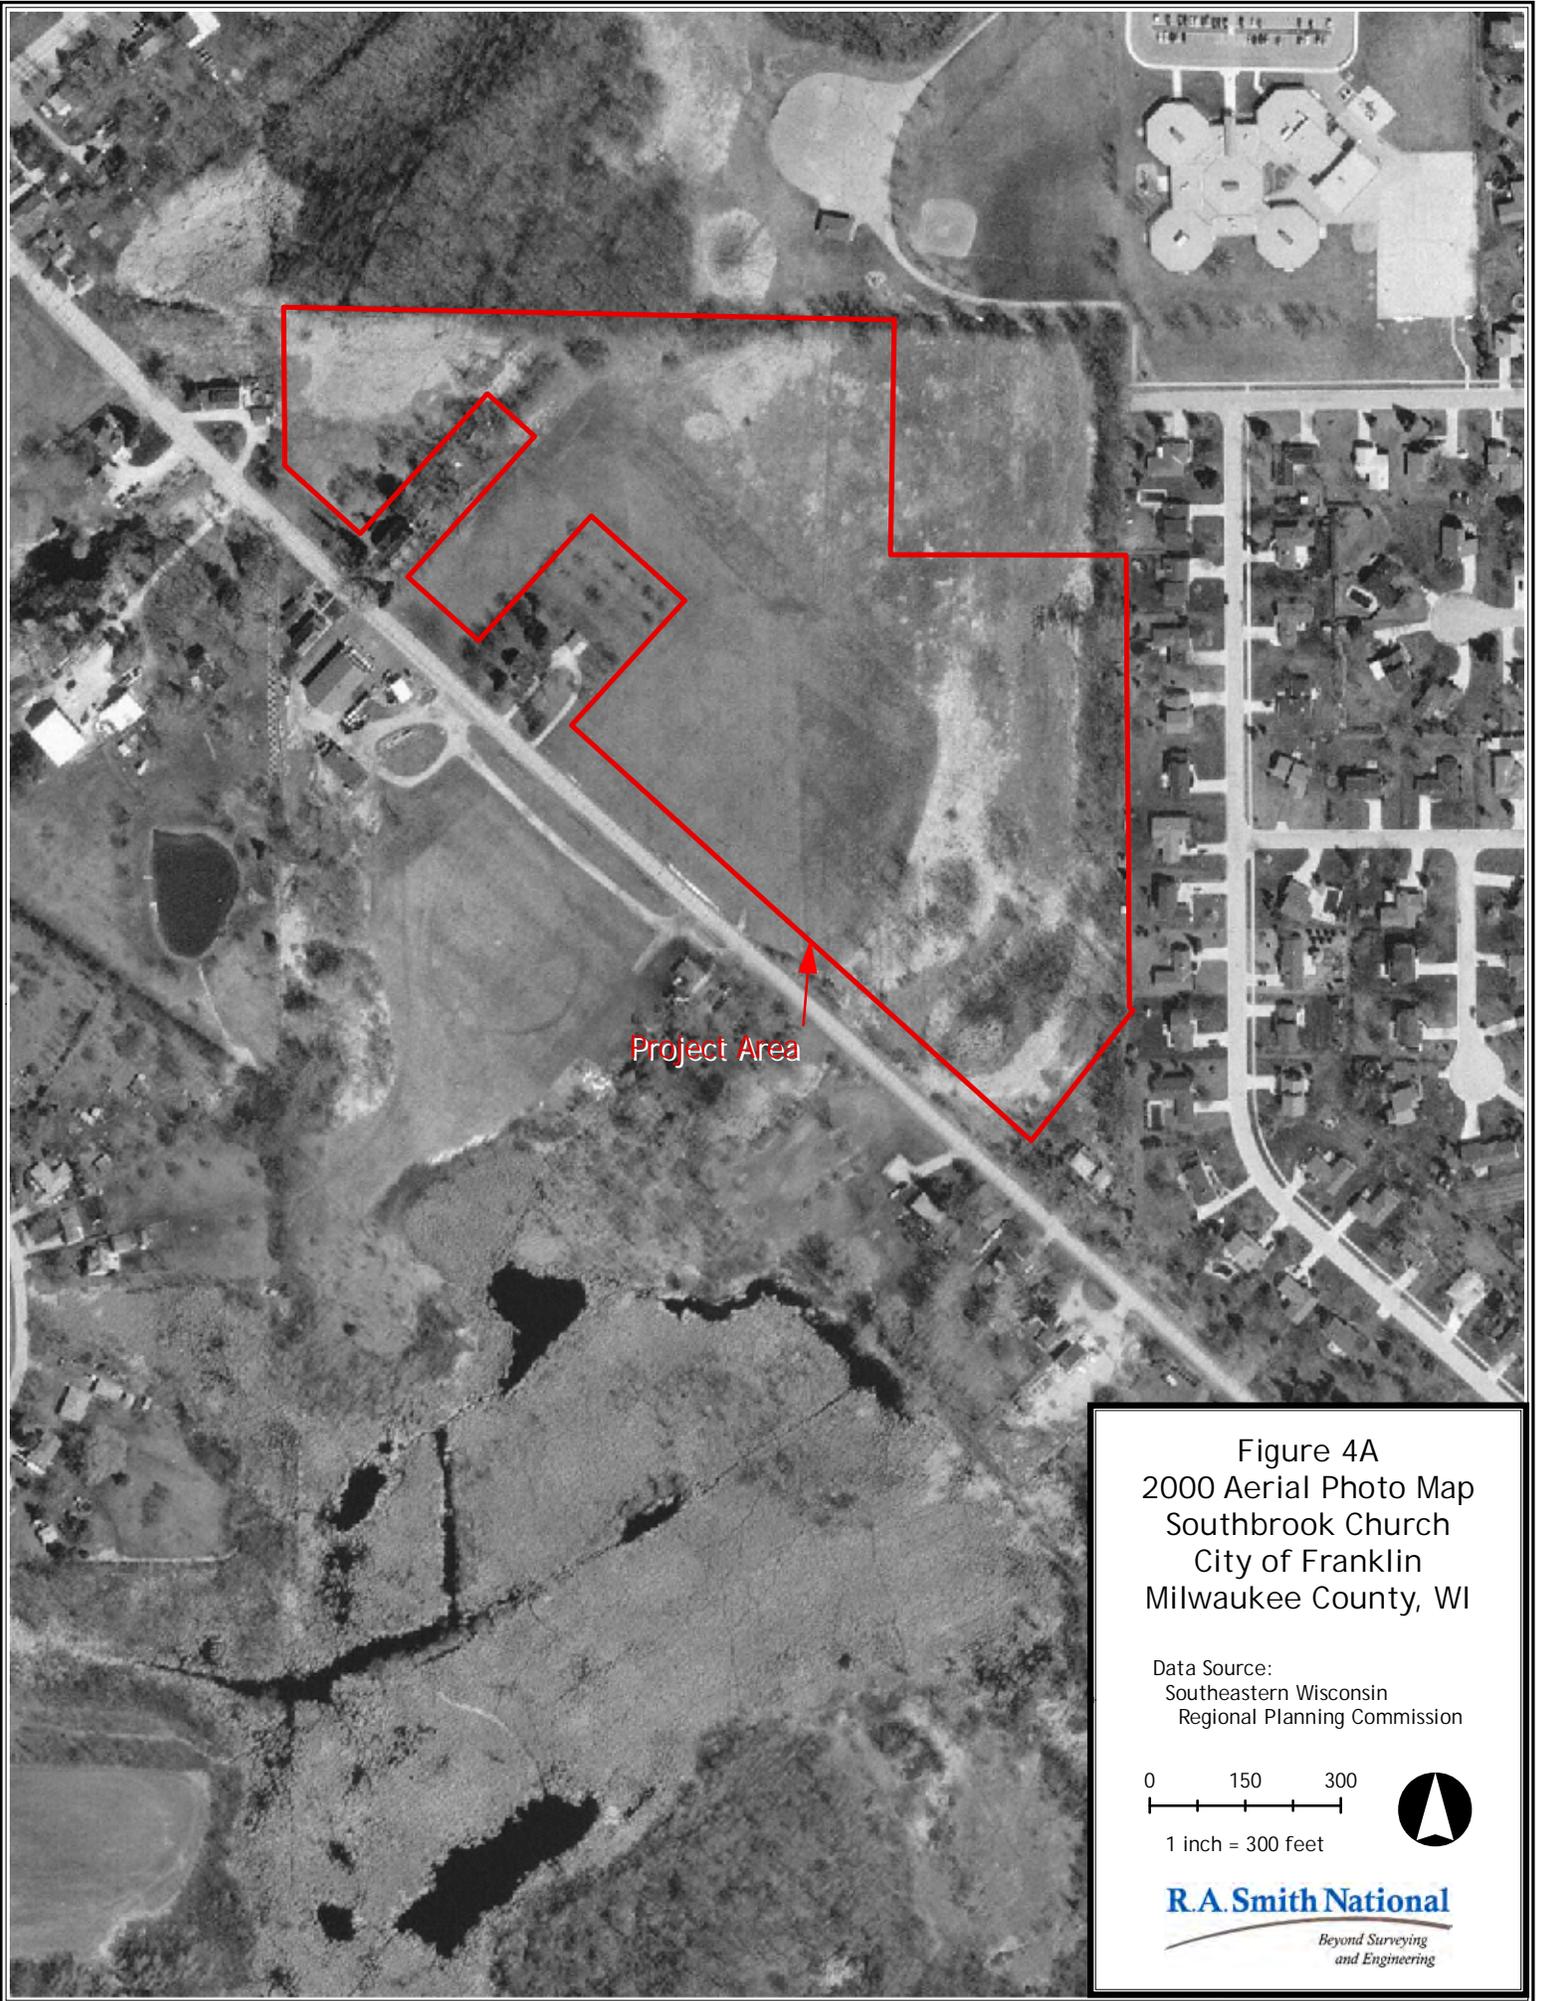
Figure 4A
2000 Aerial Photo Map
Southbrook Church
City of Franklin
Milwaukee County, WI

Data Source:
Southeastern Wisconsin
Regional Planning Commission

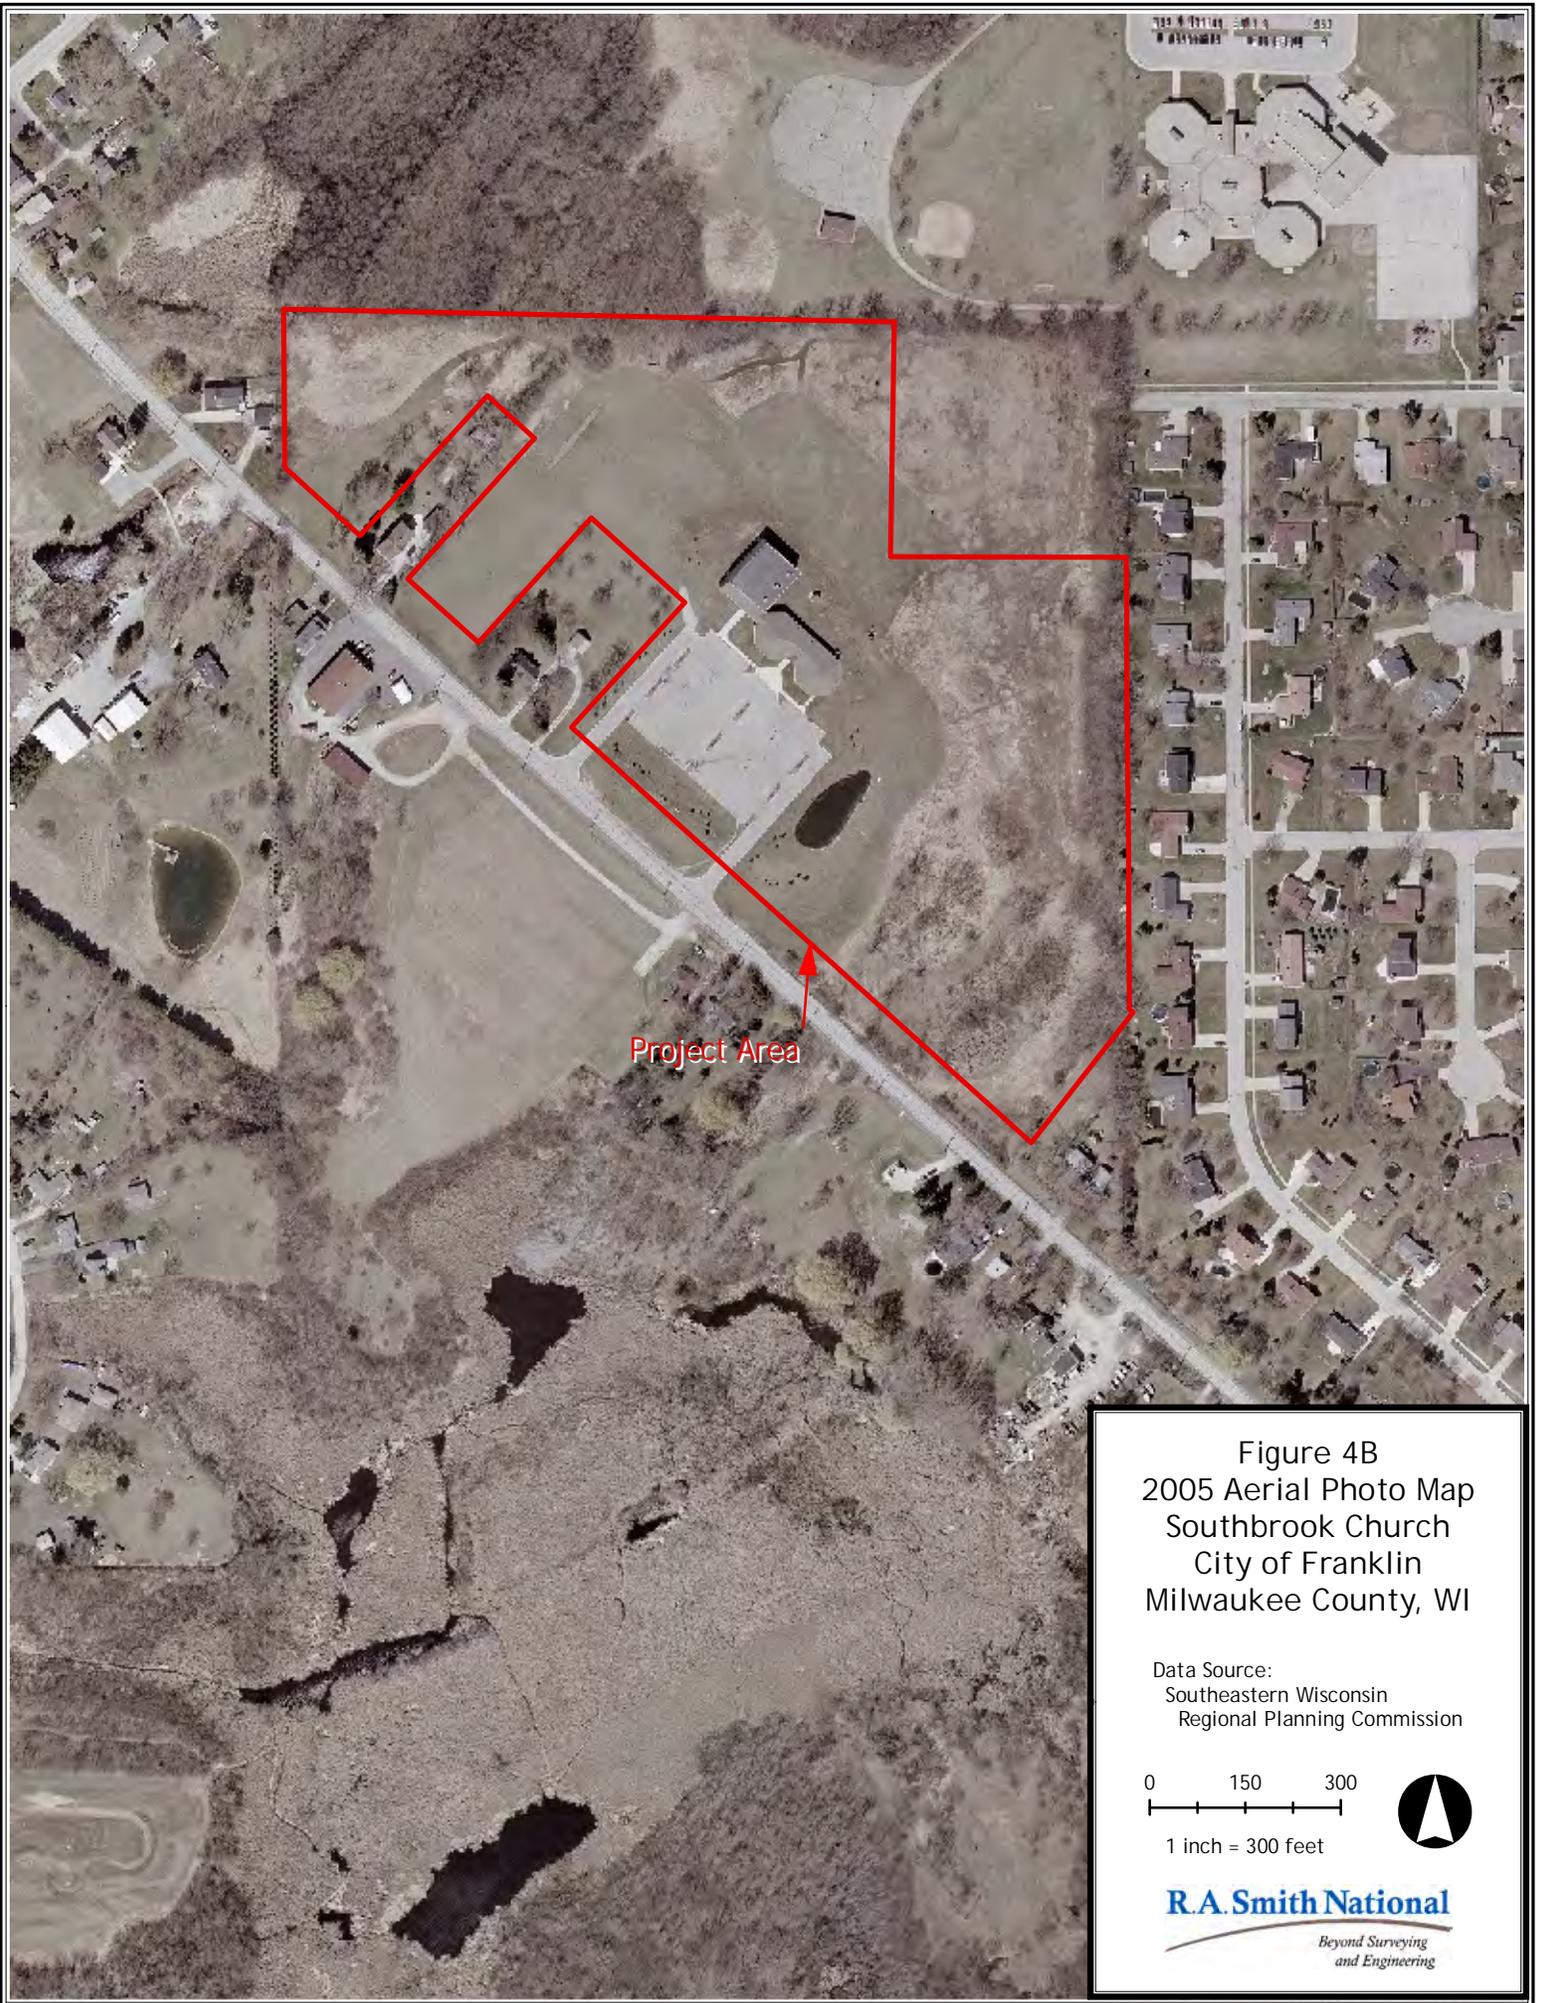
Figure 4B
2005 Aerial Photo Map
Southbrook Church
City of Franklin
Milwaukee County, WI

Data Source:
Southeastern Wisconsin
Regional Planning Commission

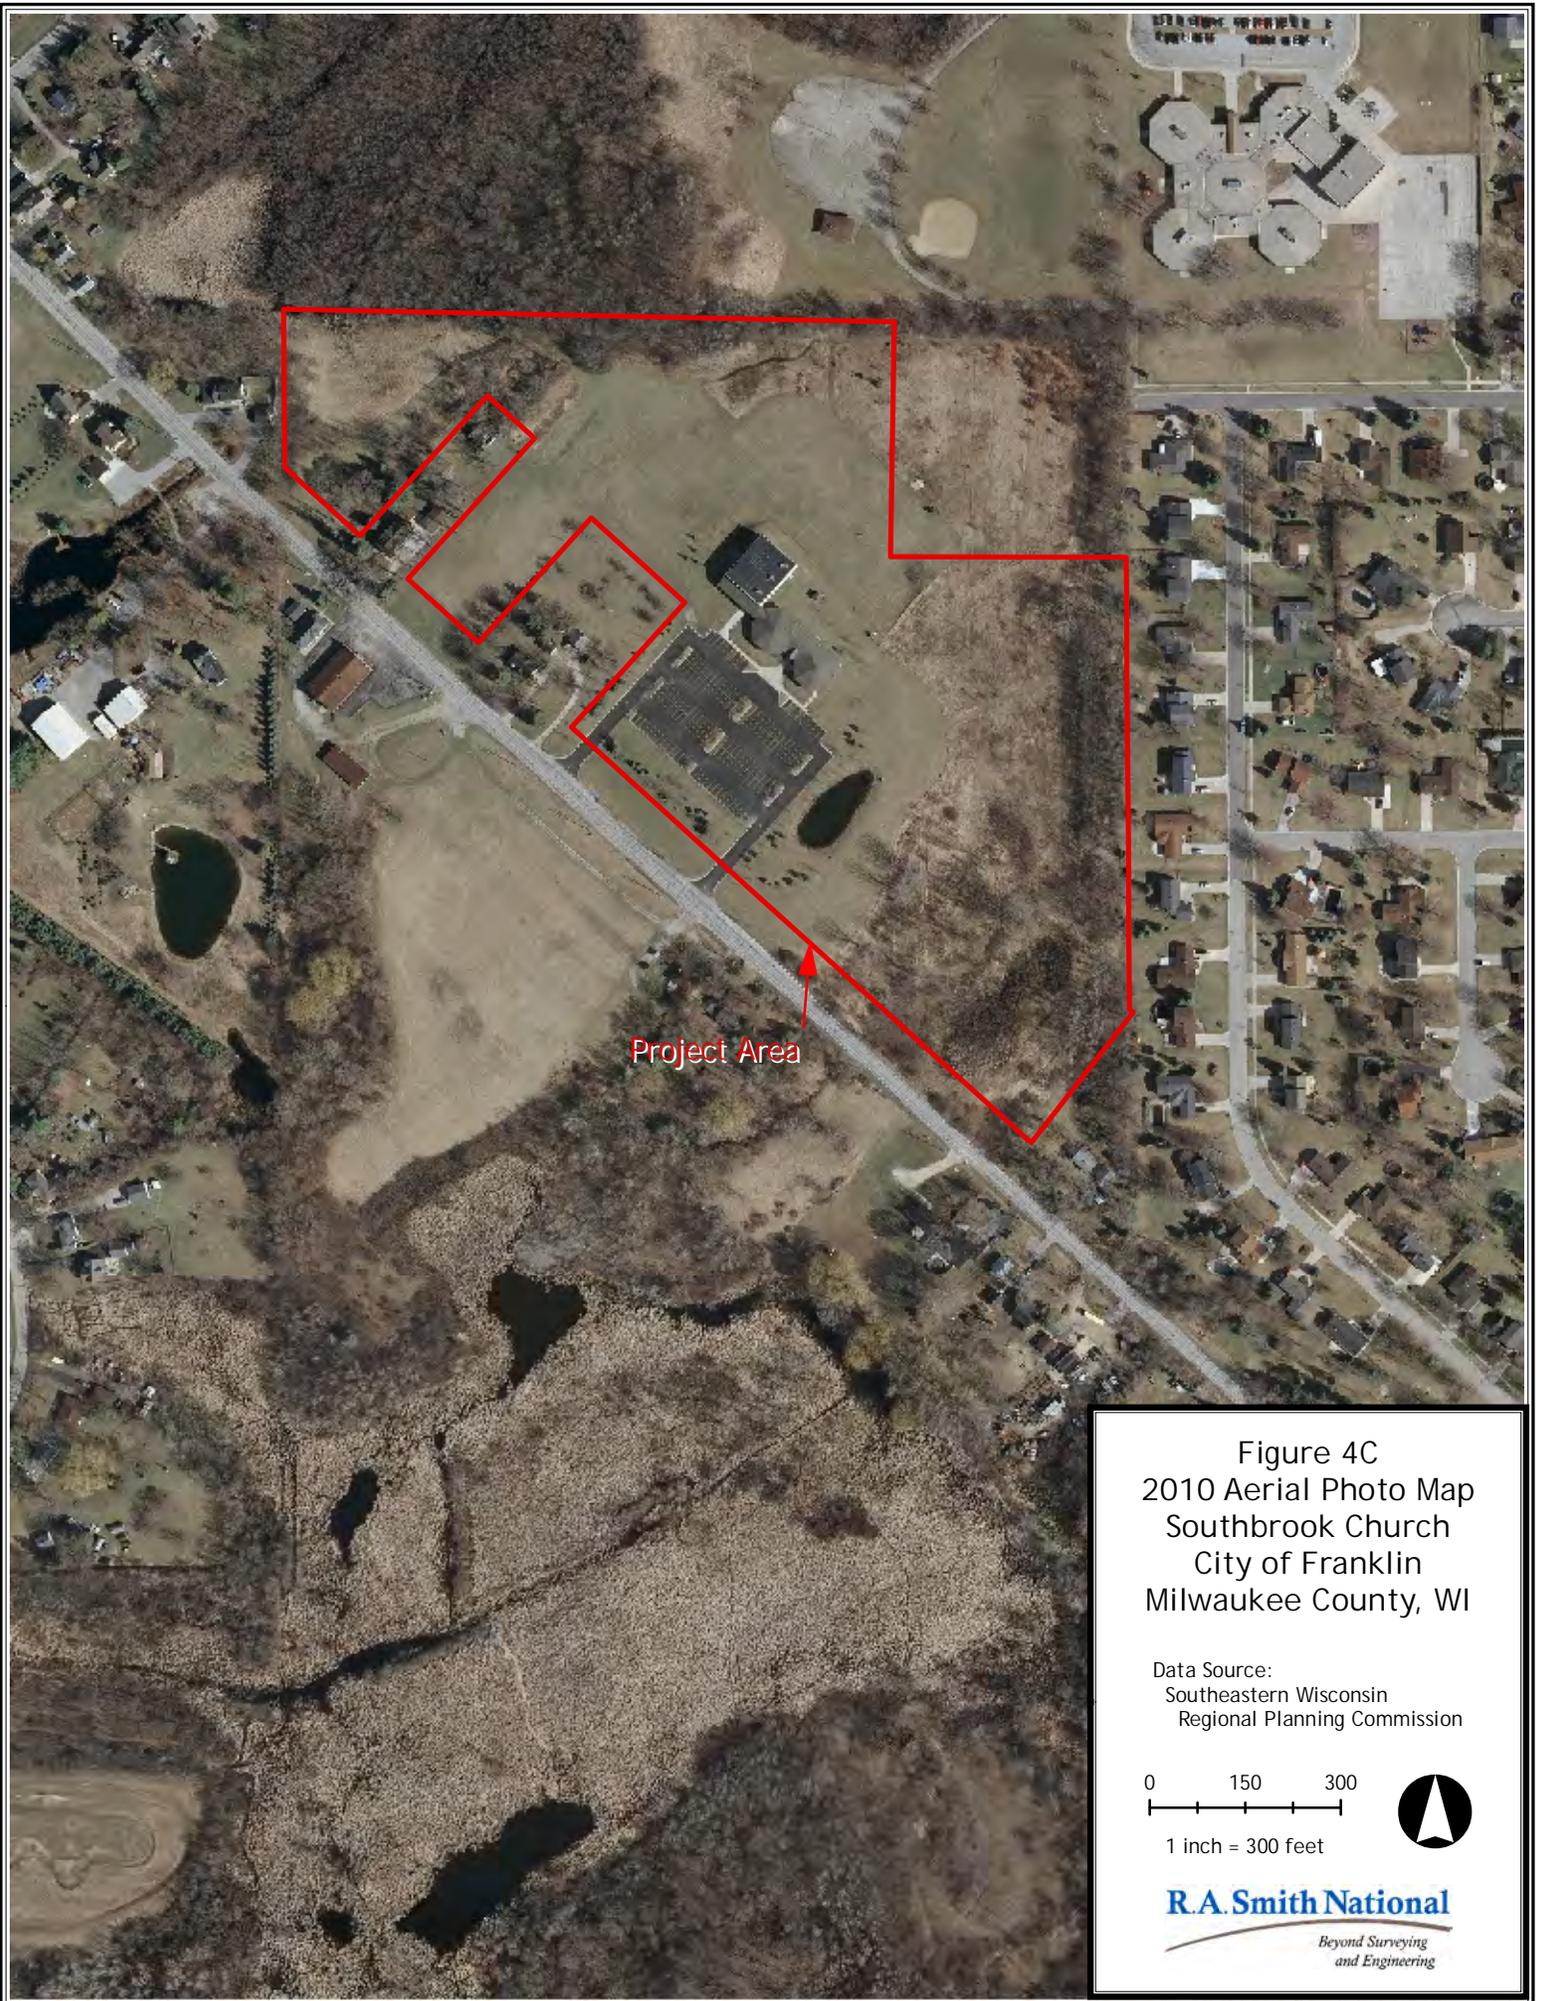
Figure 4C
2010 Aerial Photo Map
Southbrook Church
City of Franklin
Milwaukee County, WI

Project Area

Data Source:
Southeastern Wisconsin
Regional Planning Commission

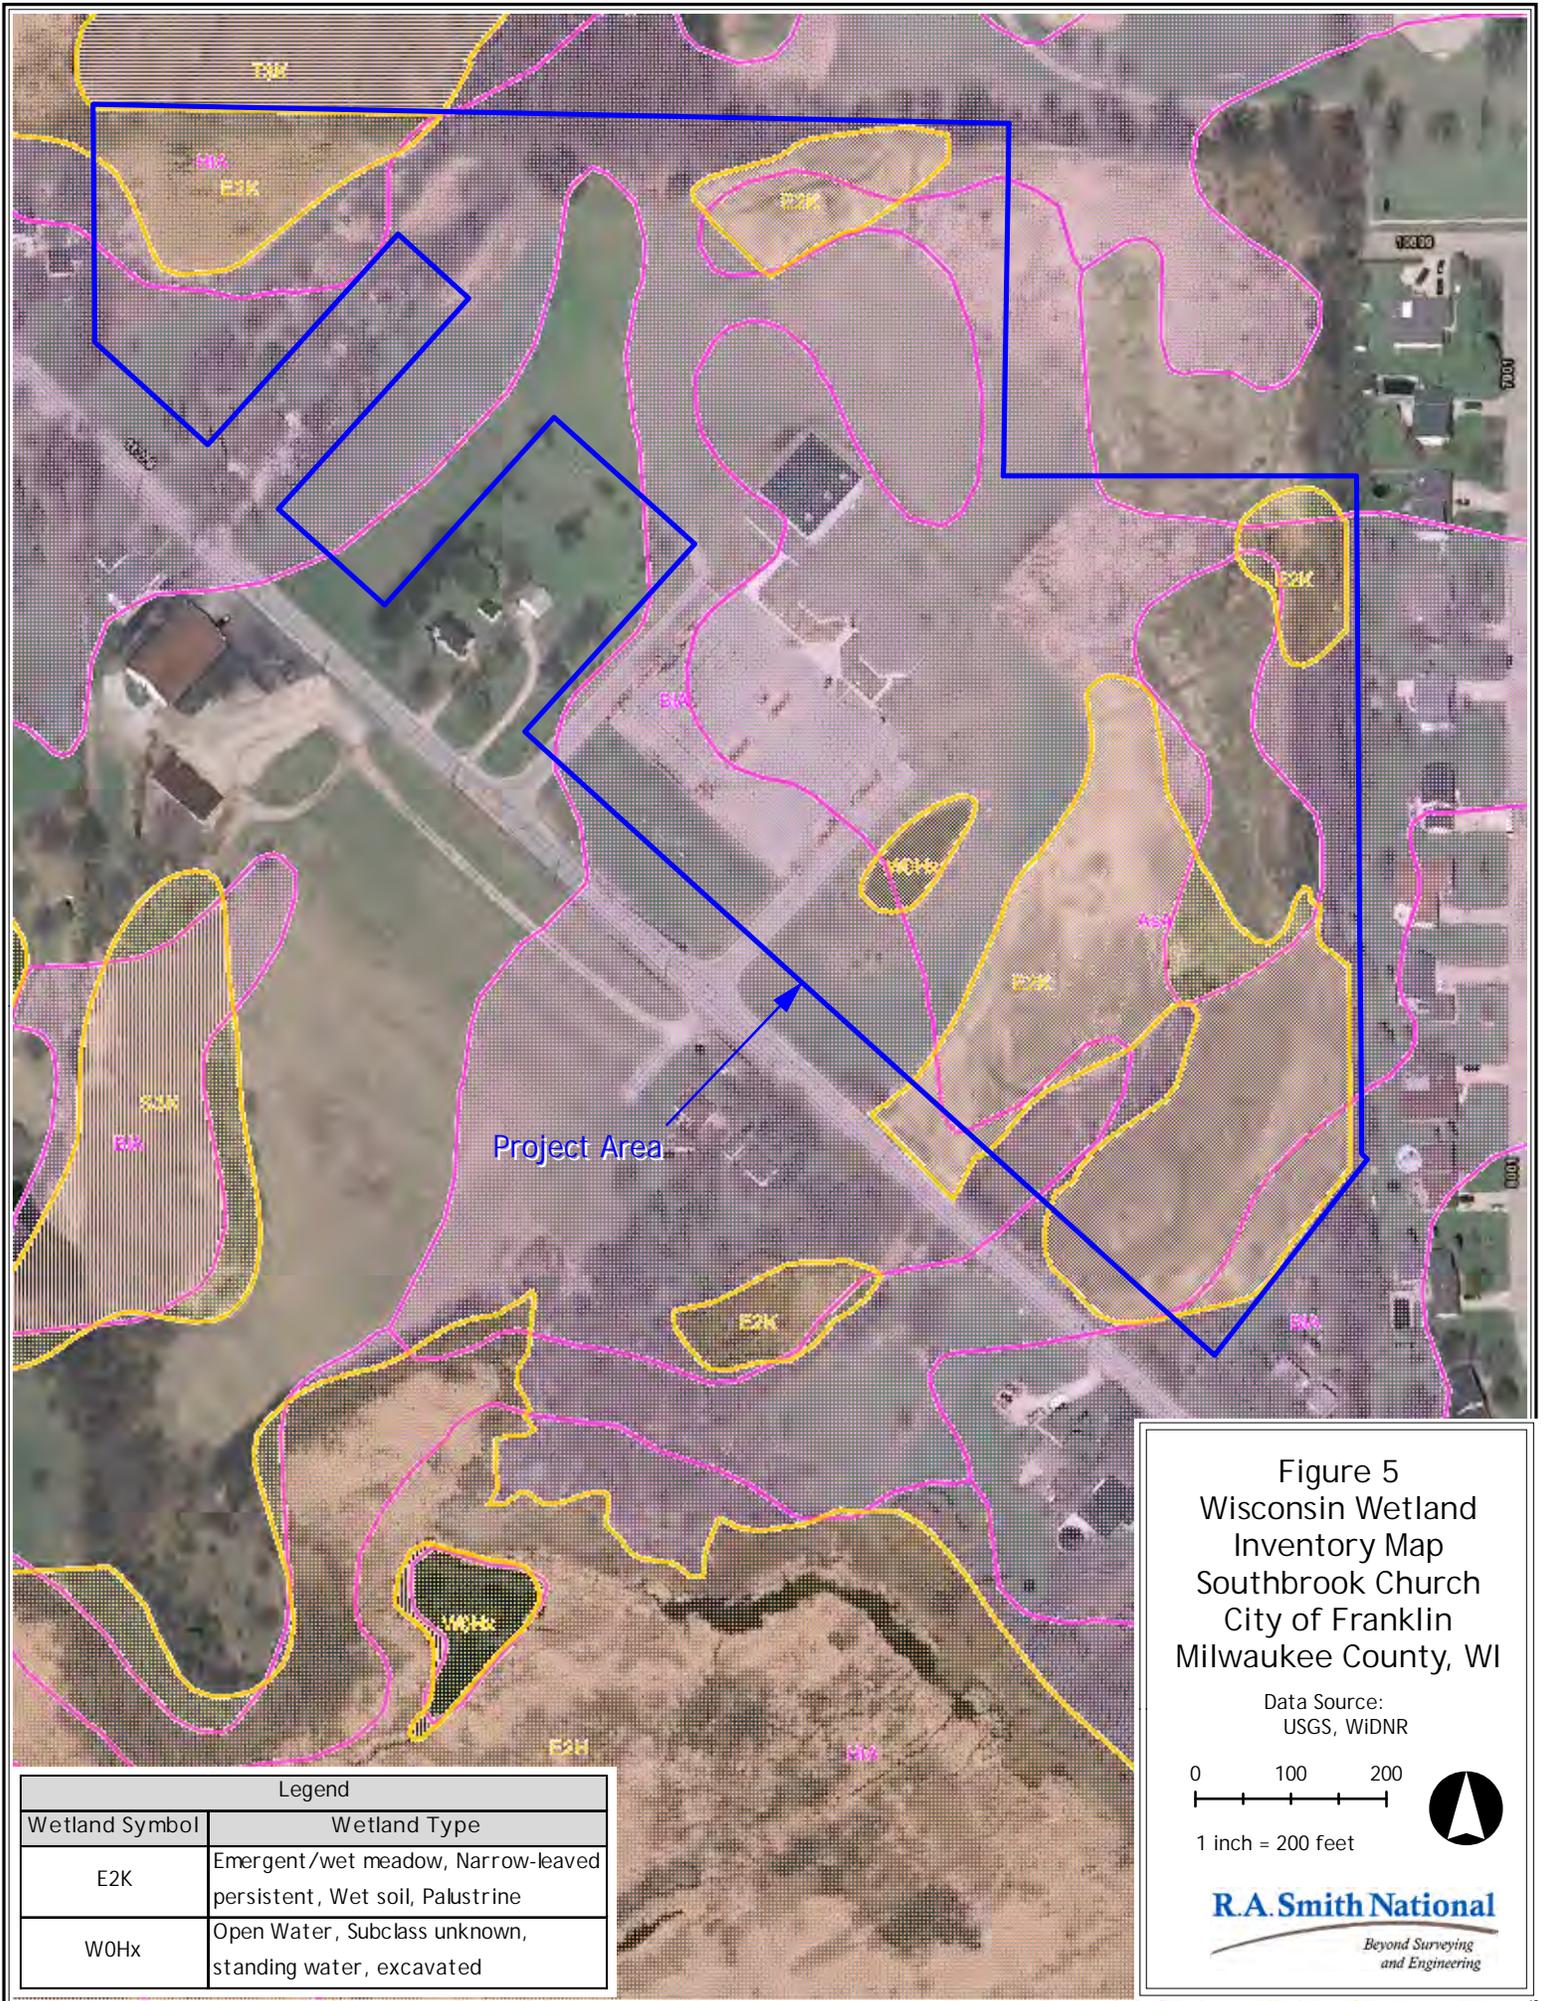
Figure 5
 Wisconsin Wetland
 Inventory Map
 Southbrook Church
 City of Franklin
 Milwaukee County, WI

Legend	
Wetland Symbol	Wetland Type
E2K	Emergent/wet meadow, Narrow-leaved persistent, Wet soil, Palustrine
W0Hx	Open Water, Subclass unknown, standing water, excavated

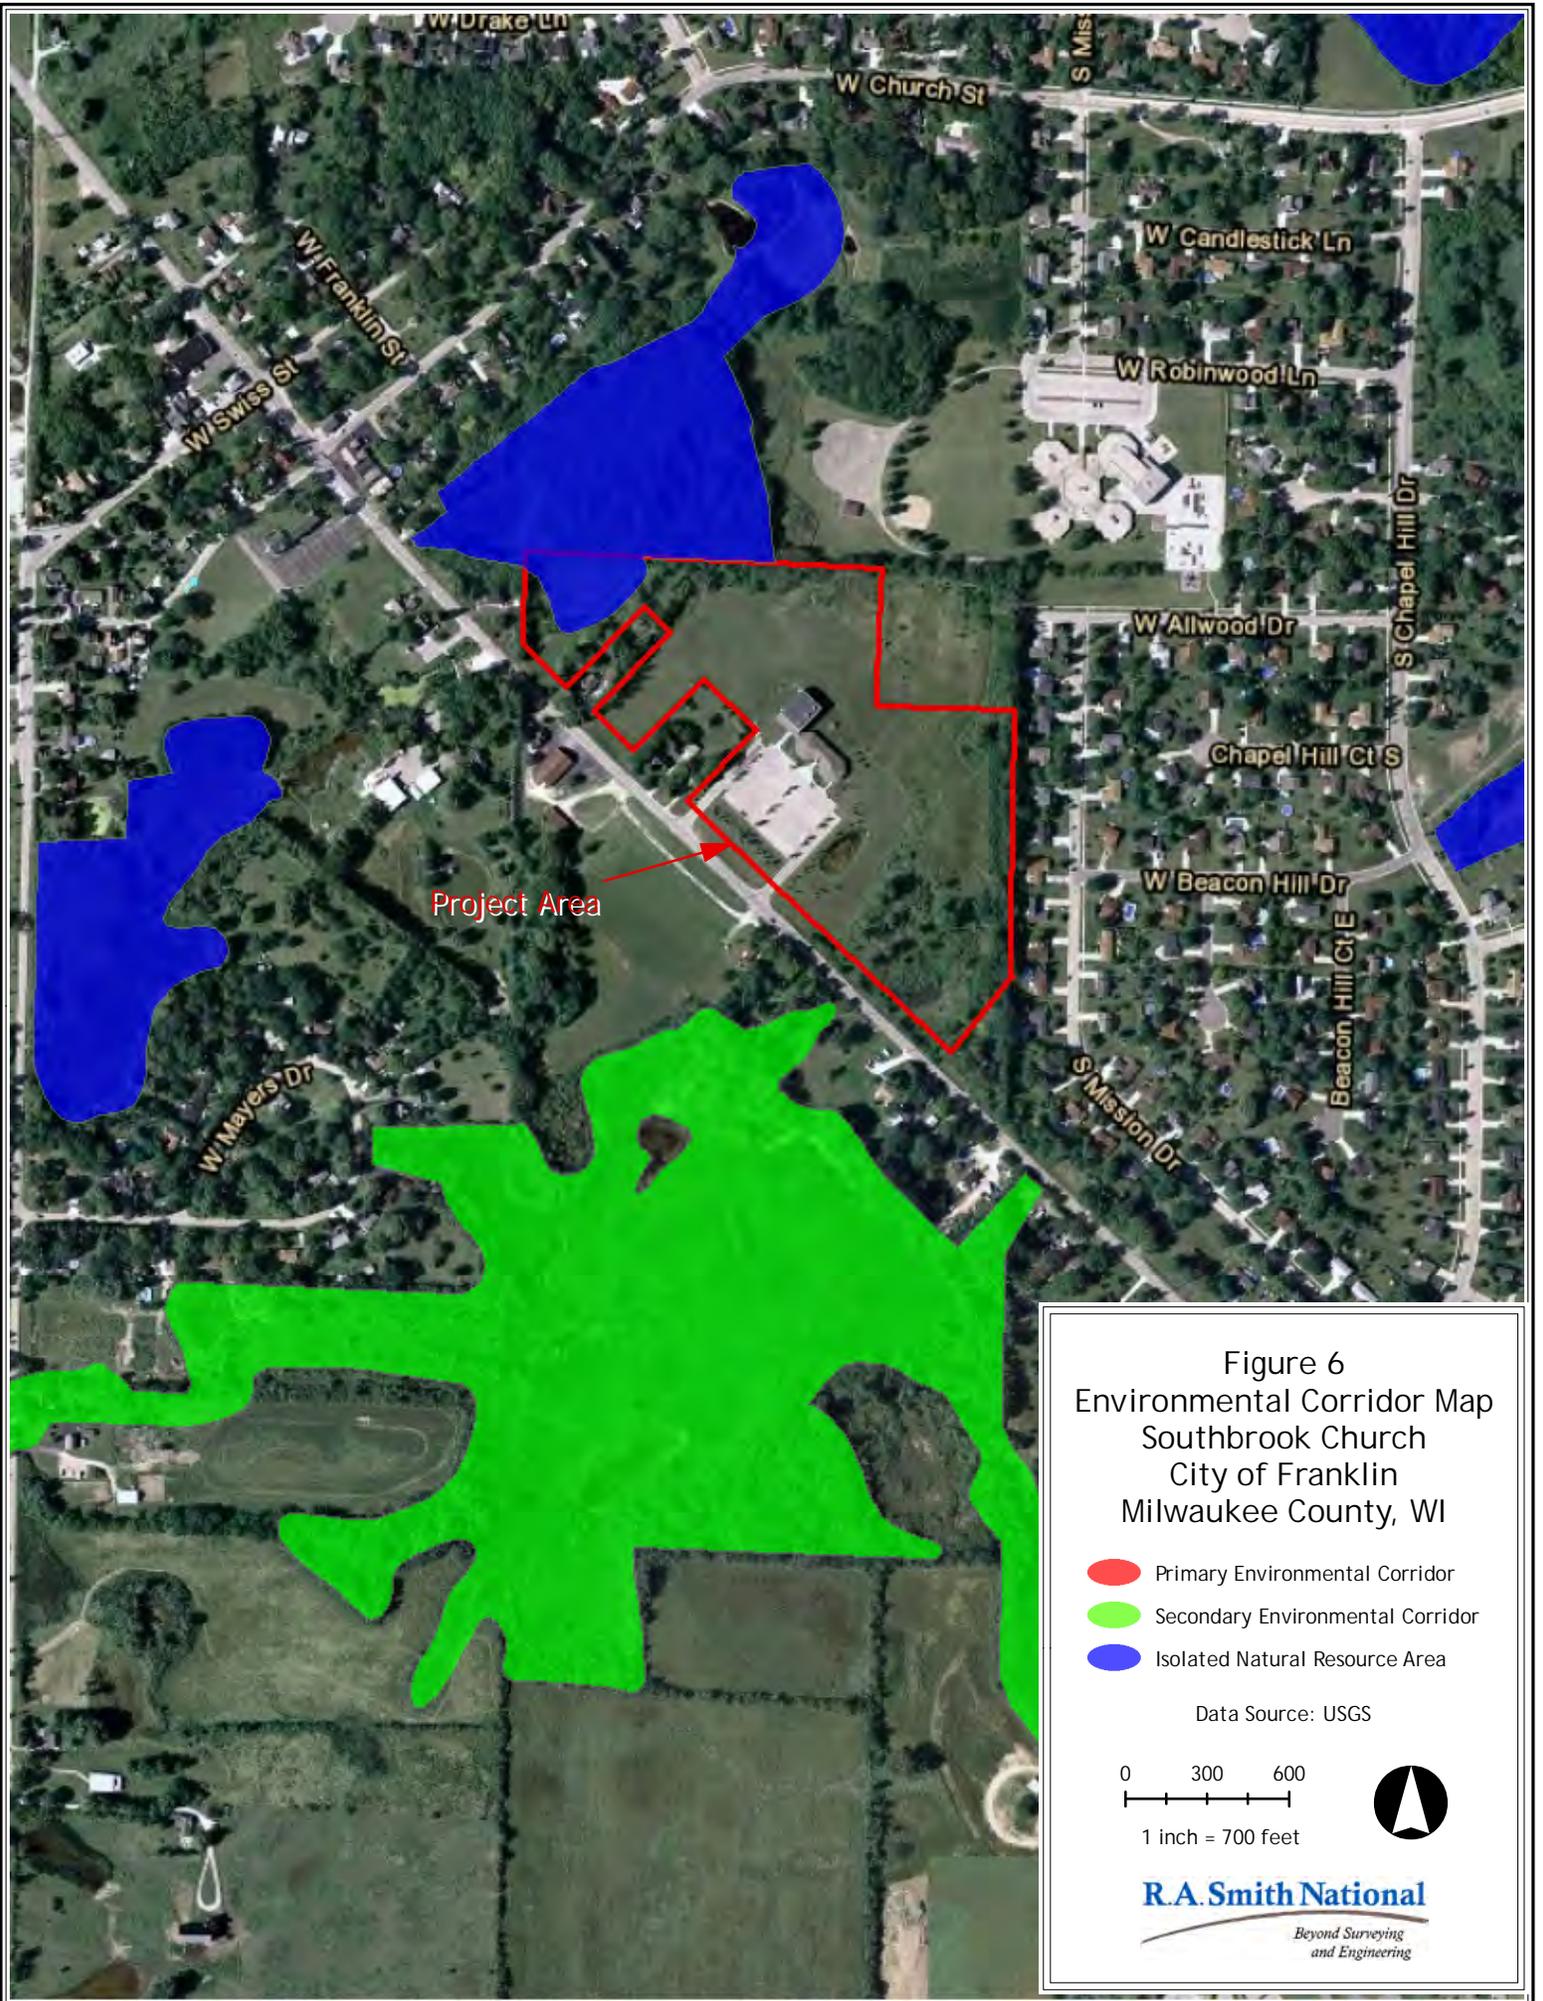
Figure 6
 Environmental Corridor Map
 Southbrook Church
 City of Franklin
 Milwaukee County, WI

- Primary Environmental Corridor
- Secondary Environmental Corridor
- Isolated Natural Resource Area
