Wetland Delineation Report.....1-6

Figure 2. Wetland/Waterway Boundary Map
 Southbrook Church
 City of Franklin
 Milwaukee County, WI

Figure 3
 NRCS Web Soil Survey Map
 Southbrook Church
 City of Franklin
 Milwaukee County, WI

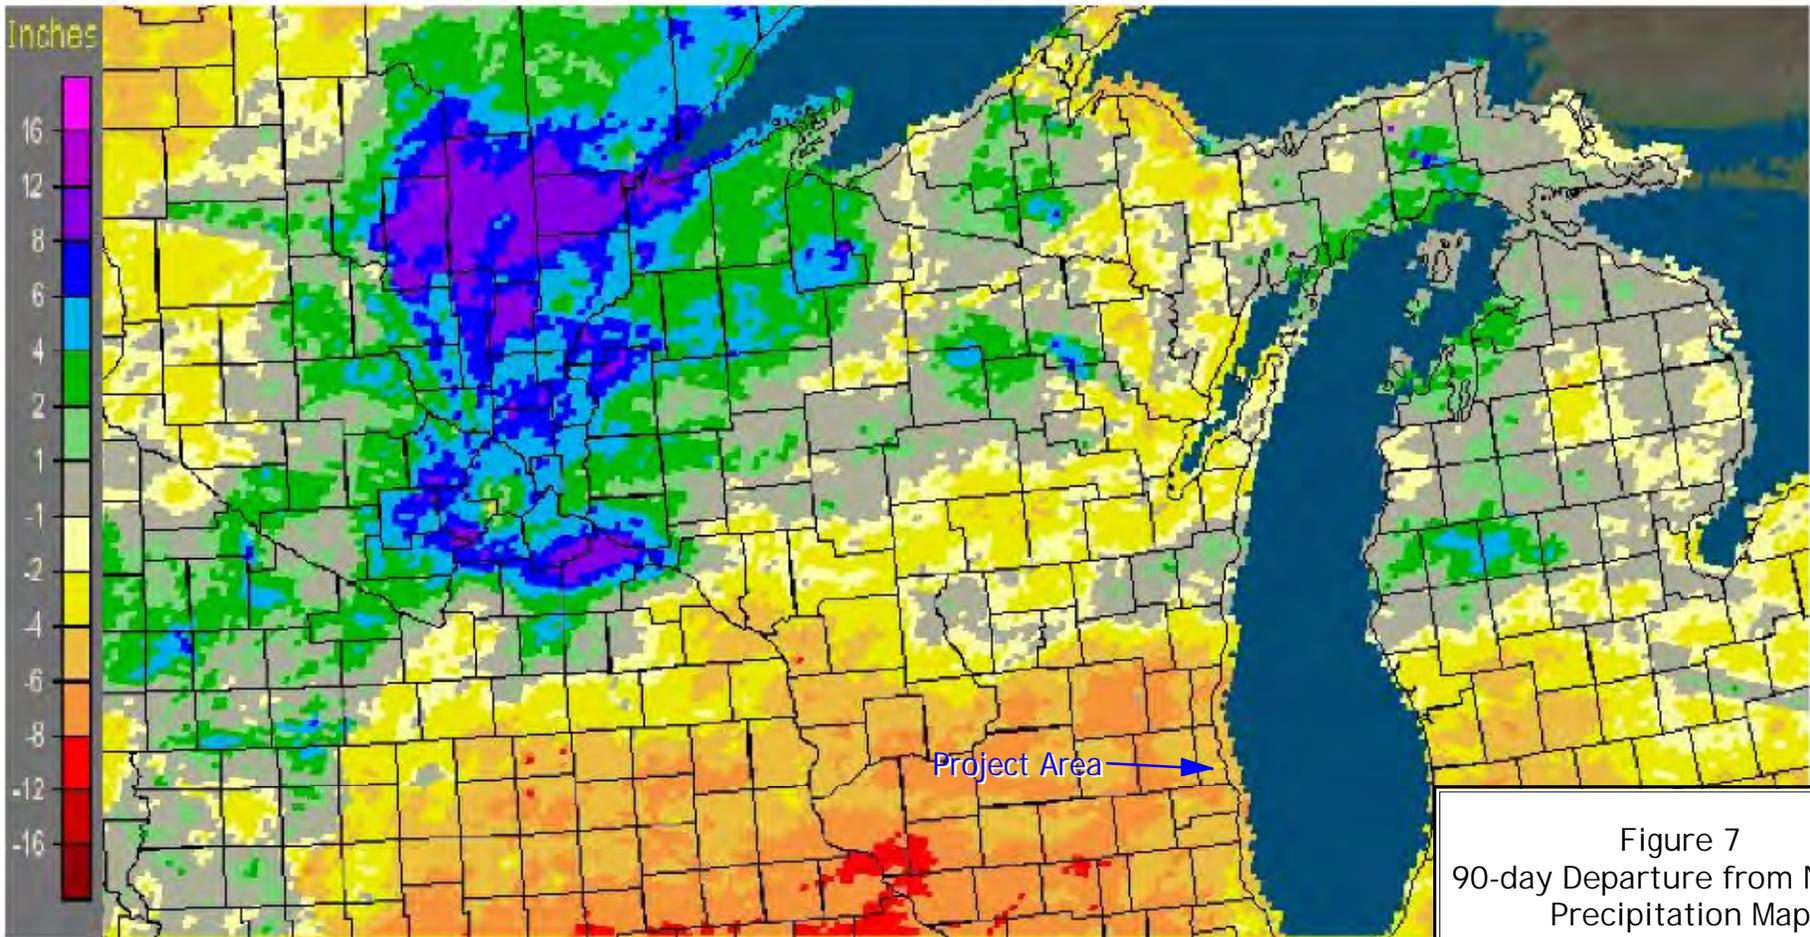
Figure 7
90-day Departure from Normal
Precipitation Map
Southbrook Church
City of Franklin
Milwaukee County, WI

The project area falls within
-4" to -6" of the normal
precipitation range.

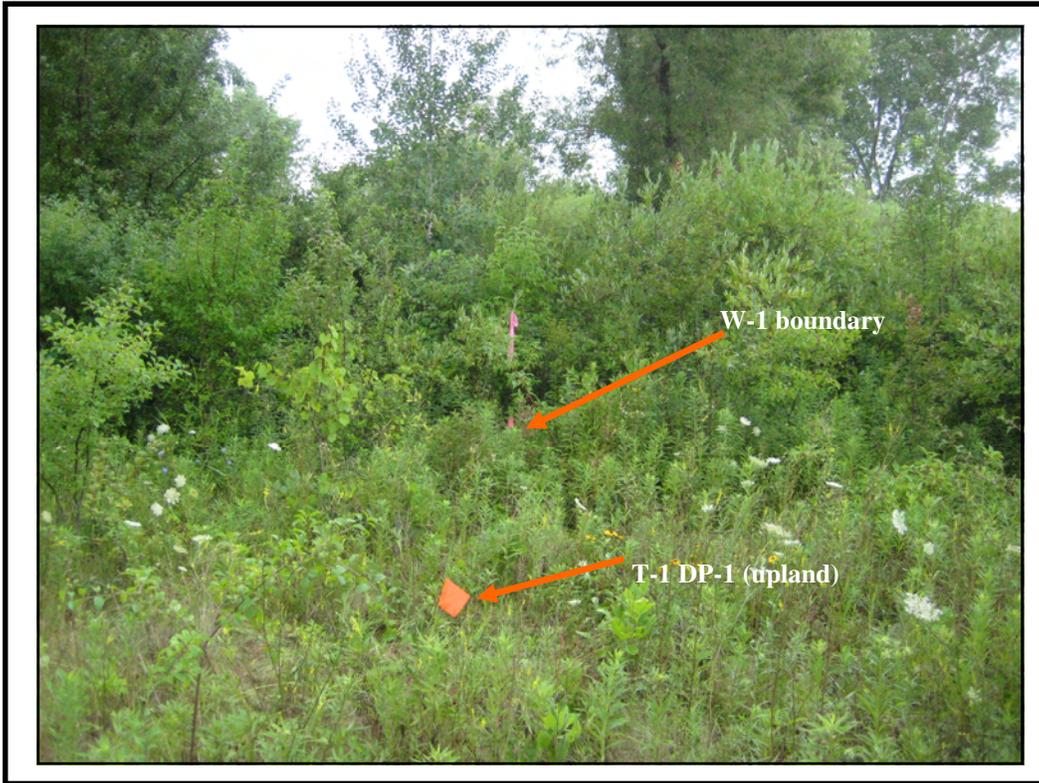
Photograph 1 (7/24/2012): South facing view of T-1 towards W-1.

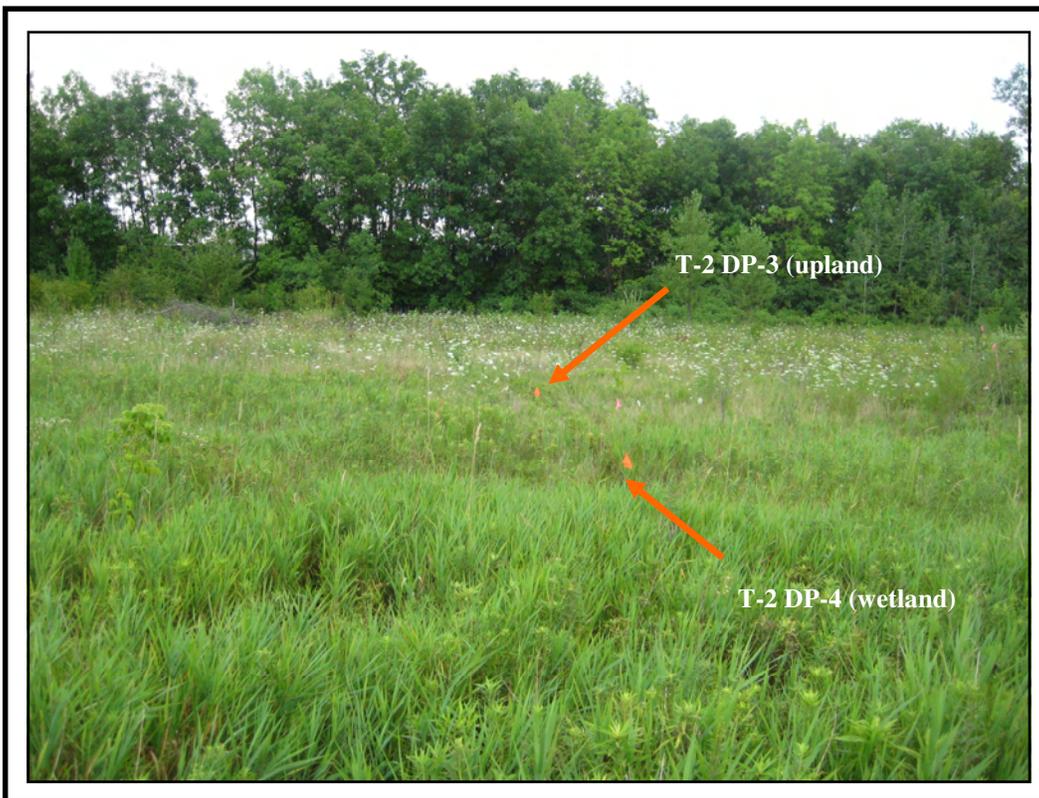
Photograph 2 (7/24/2012): East facing view of Transect 2 near northwestern portion of W-1.

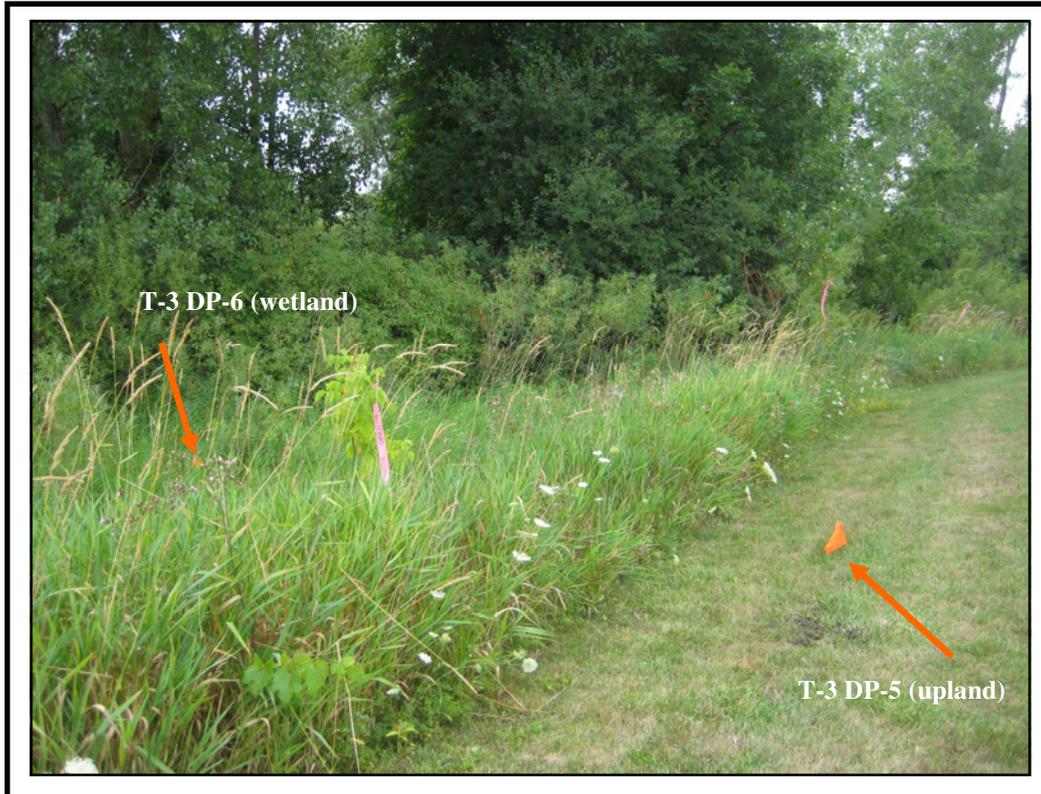
Photograph 3 (7/24/2012): South view of Transect 3 along the western boundary of W-1.

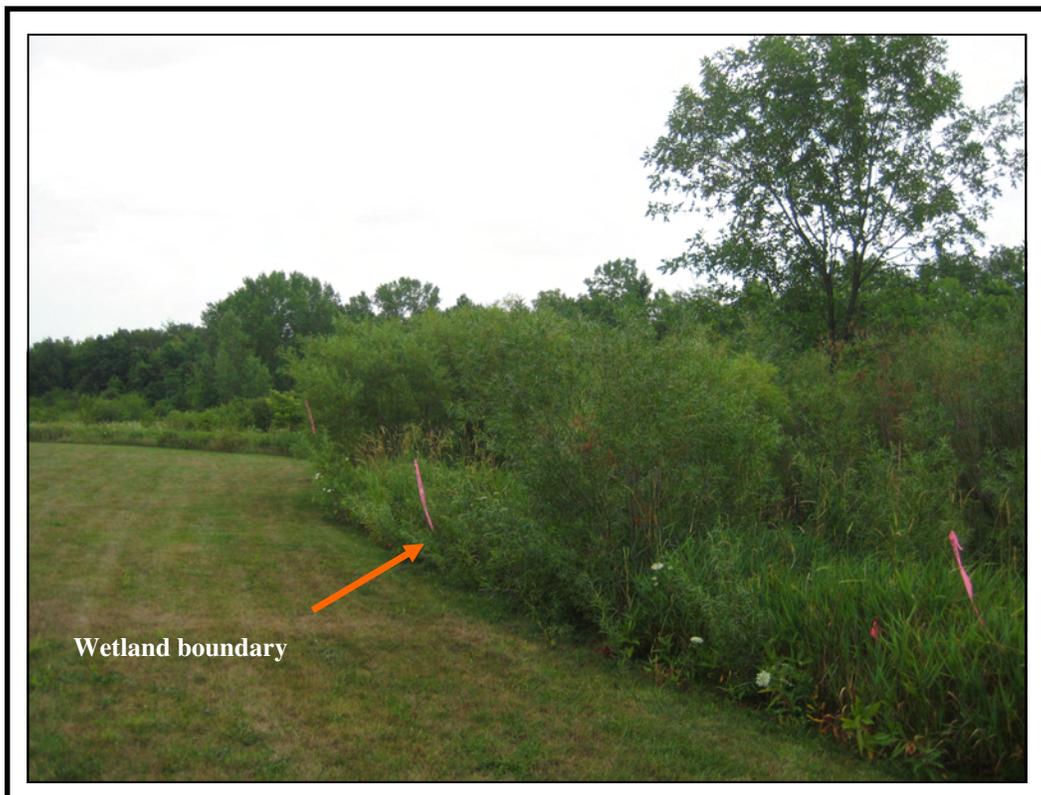
Photograph 4 (7/24/2012): North facing view of the western boundary of W-1.

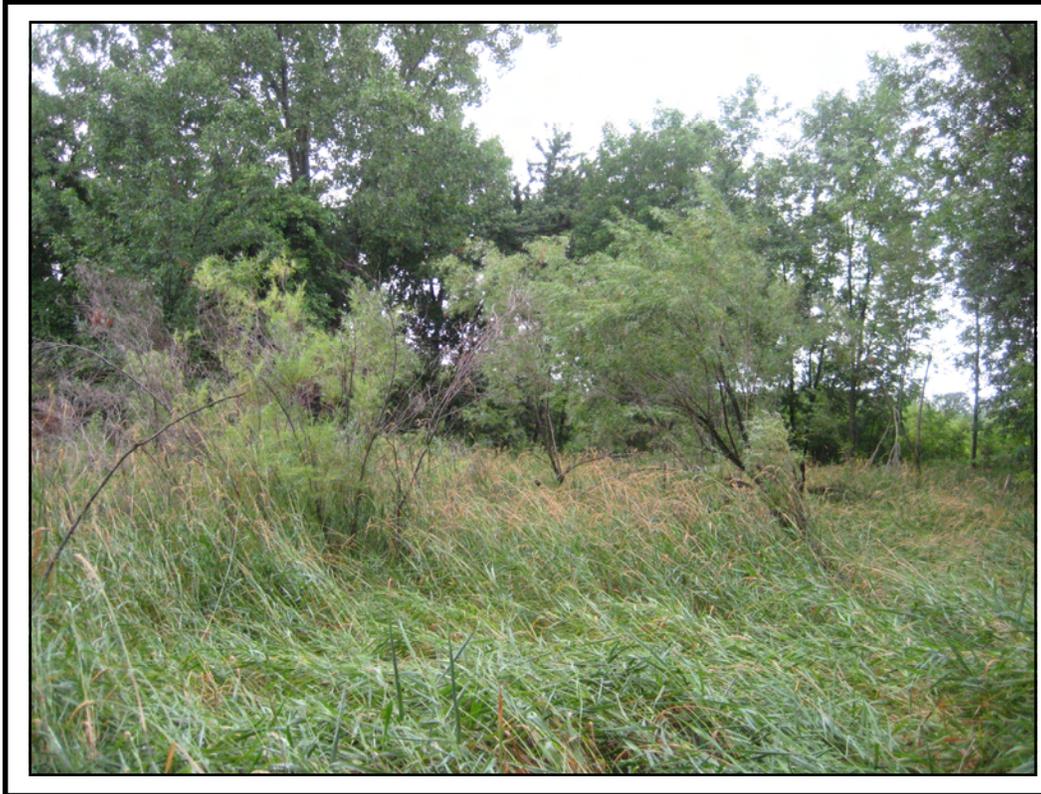
Photograph 5 (7/24/2012): Interior view of the northeastern portion of W-1.

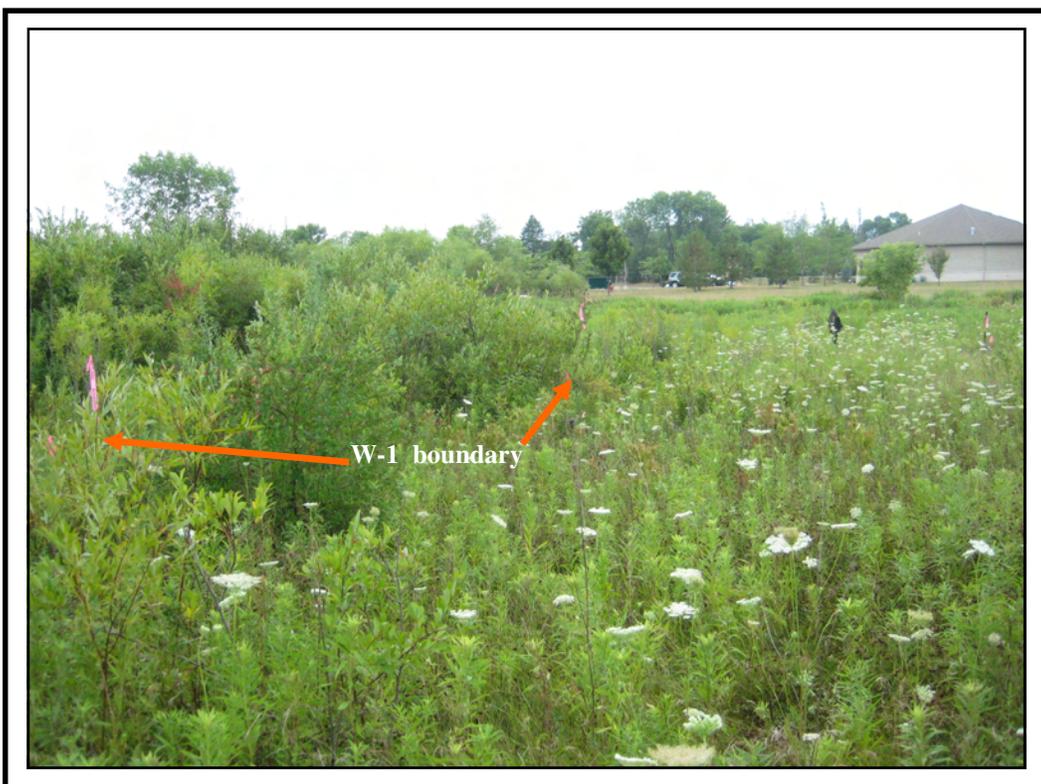
Photograph 6 (7/24/2012): Facing northwest along W-1 boundary from T-1. Shrub carr wetland is left of the flag and upland "old-field" is to the right.

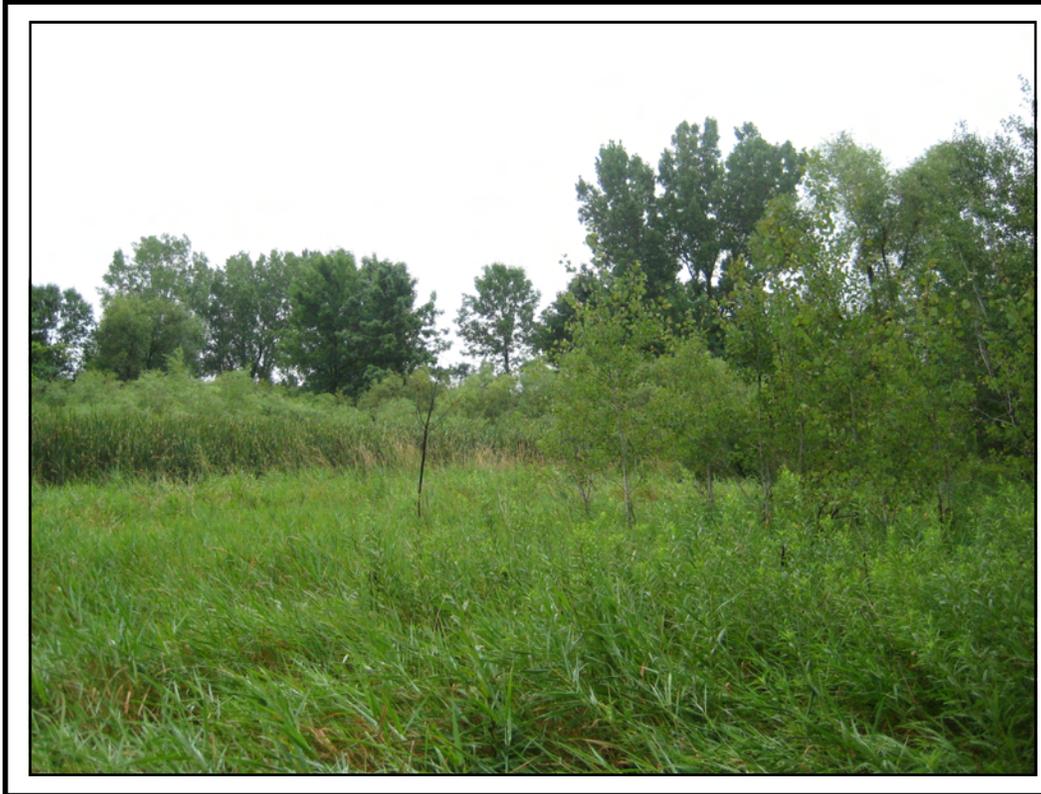
Photograph 7 (7/24/2012): Northeast view of interior of W-1 from the southeast portion of W-1. Note the shallow marsh community in the background.

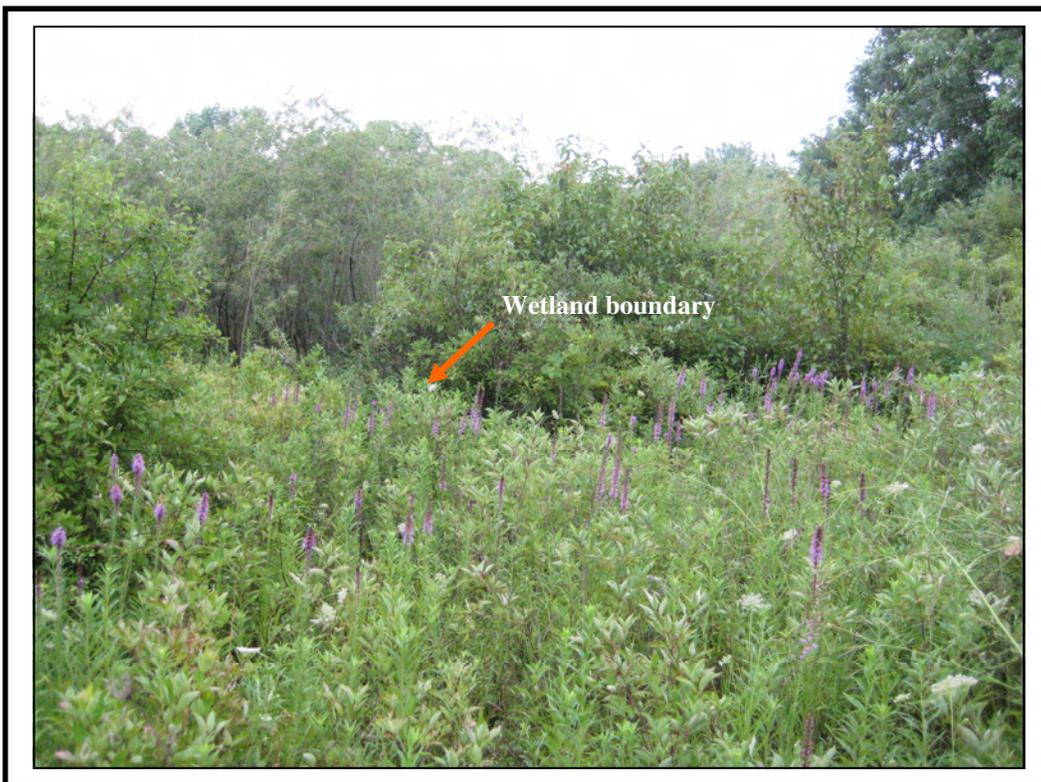
Photograph 8 (7/24/2012): Upland peninsula within W-1. Shrub carr wetland is in the background and upland prairie remnant is in the foreground.

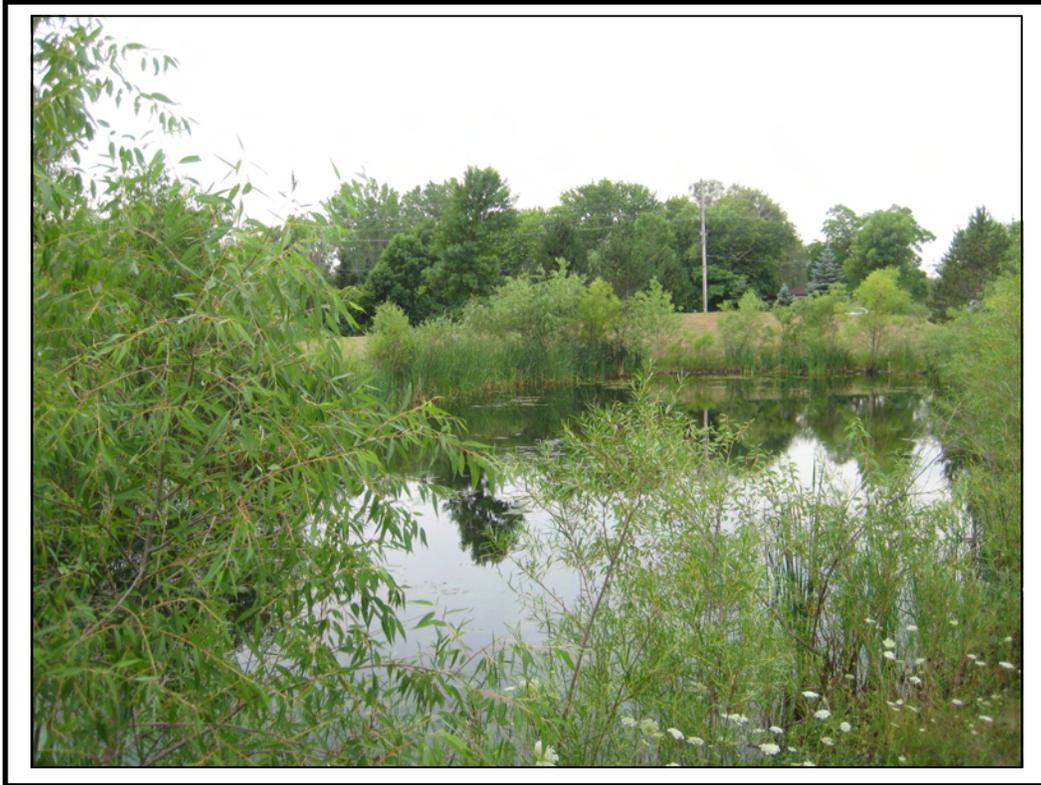
Photograph 9 (7/24/2012): South facing view of the stormwater pond that was built in 2002 during the construction of the church. The stormwater pond is exempt from NR103 regulation.

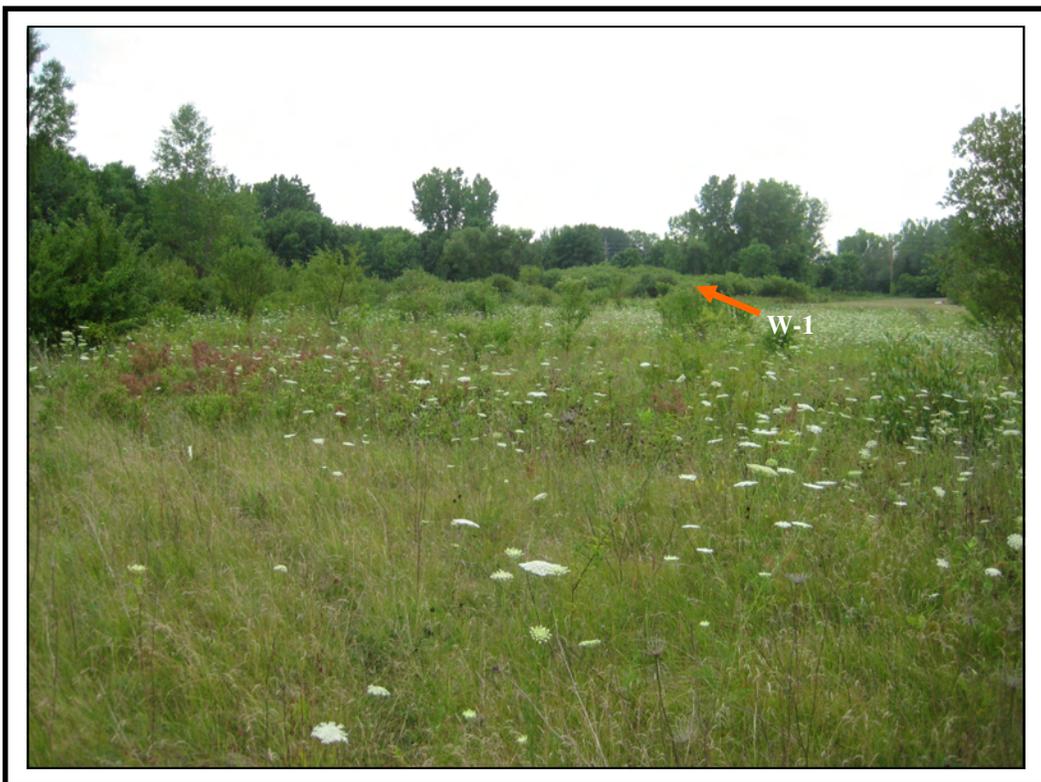
Photograph 10 (7/24/2012): South facing view of a typical upland plant community within the site. Uplands are dominated by cool season grasses and Queen Anne's lace. W-1 is in the background.
