COUNCIL ACTION REQUESTED

A RESOLUTION CONDITIONALLY APPROVING A 2 LOT CERTIFIED SURVEY MAP, BEING LOT 1 OF CERTIFIED SURVEY MAP NO. 6543, RECORDED ON AUGUST 7, 1998, REEL 43667, IMAGES 1756 TO 1758 INCLUSIVE, AS DOCUMENT NO. 7578744, AS CORRECTED BY AFFIDAVIT OF CORRECTION RECORDED AS DOCUMENT NO. 7724864, PART OF THE NORTHEAST 1/4 AND NORTHWEST 1/4 OF THE SOUTHEAST 1/4 OF SECTION 1, TOWNSHIP 5 NORTH, RANGE 21 EAST, CITY OF FRANKLIN, MILWAUKEE COUNTY, WISCONSIN
(WS FRANKLIN LLC, APPLICANT)
(6803, 6805 AND 6807 SOUTH 27TH STREET)

Wetland Delineation Report

Approximately 10-Acre Study Area 6803 S. 27th St., City of Franklin, Milwaukee County, Wisconsin

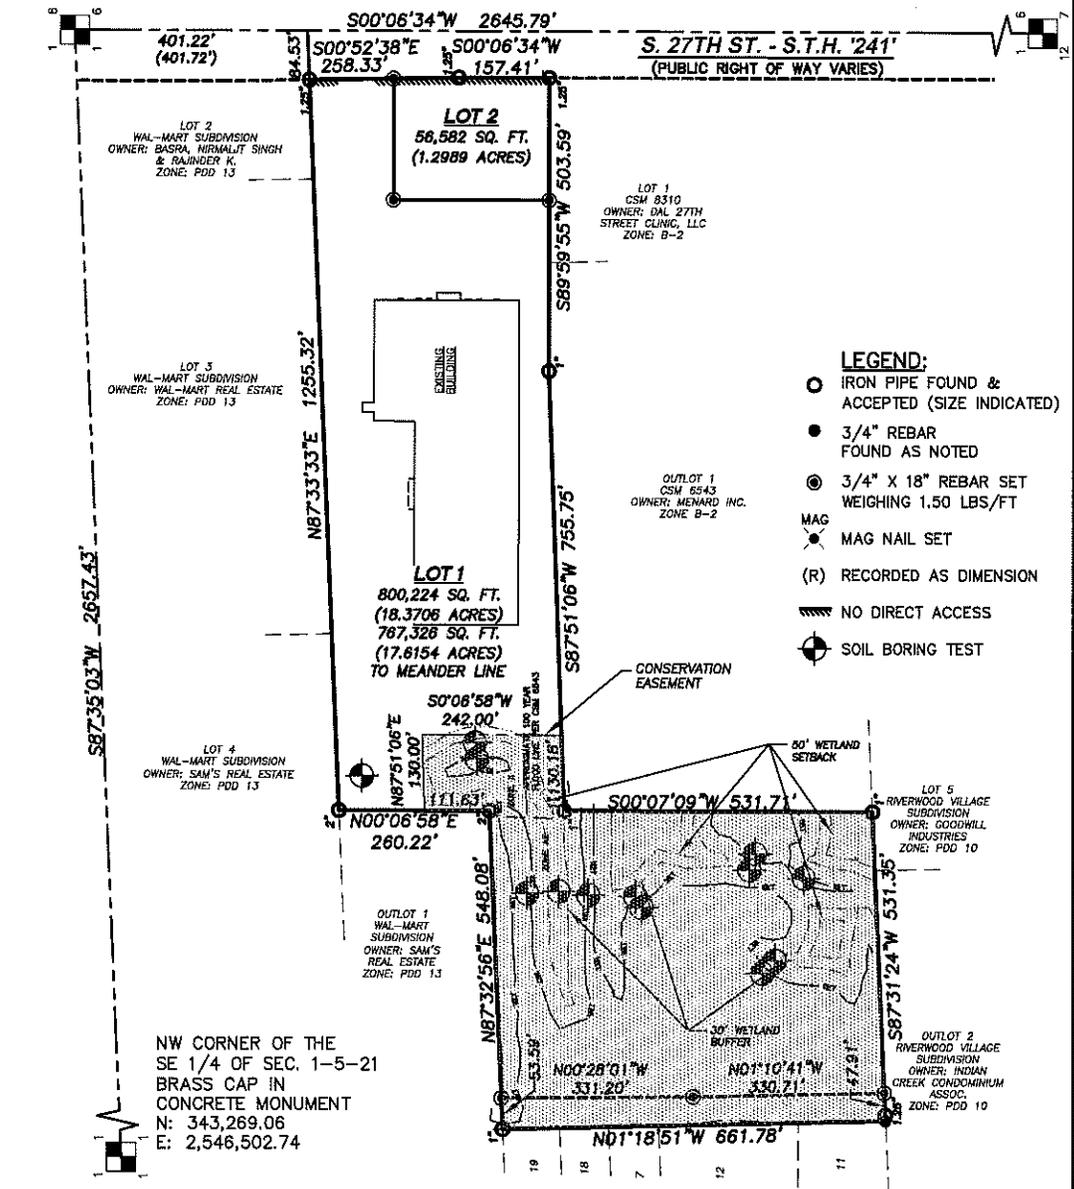
CERTIFIED SURVEY MAP No. _____

BEING A REDIVISION OF LOT 1 OF CERTIFIED SURVEY MAP No. 6543, RECORDED ON AUGUST 7, 1998 AND AS CORRECTED BY AFFIDAVIT OF CORRECTION RECORDED AS DOCUMENT No. 7724864 AND BEING A PART OF THE NORTHEAST 1/4 AND THE NORTHWEST 1/4 OF THE SOUTHEAST 1/4 OF SECTION 1, TOWNSHIP 5 NORTH, RANGE 21 EAST, CITY OF FRANKLIN, MILWAUKEE COUNTY, WISCONSIN

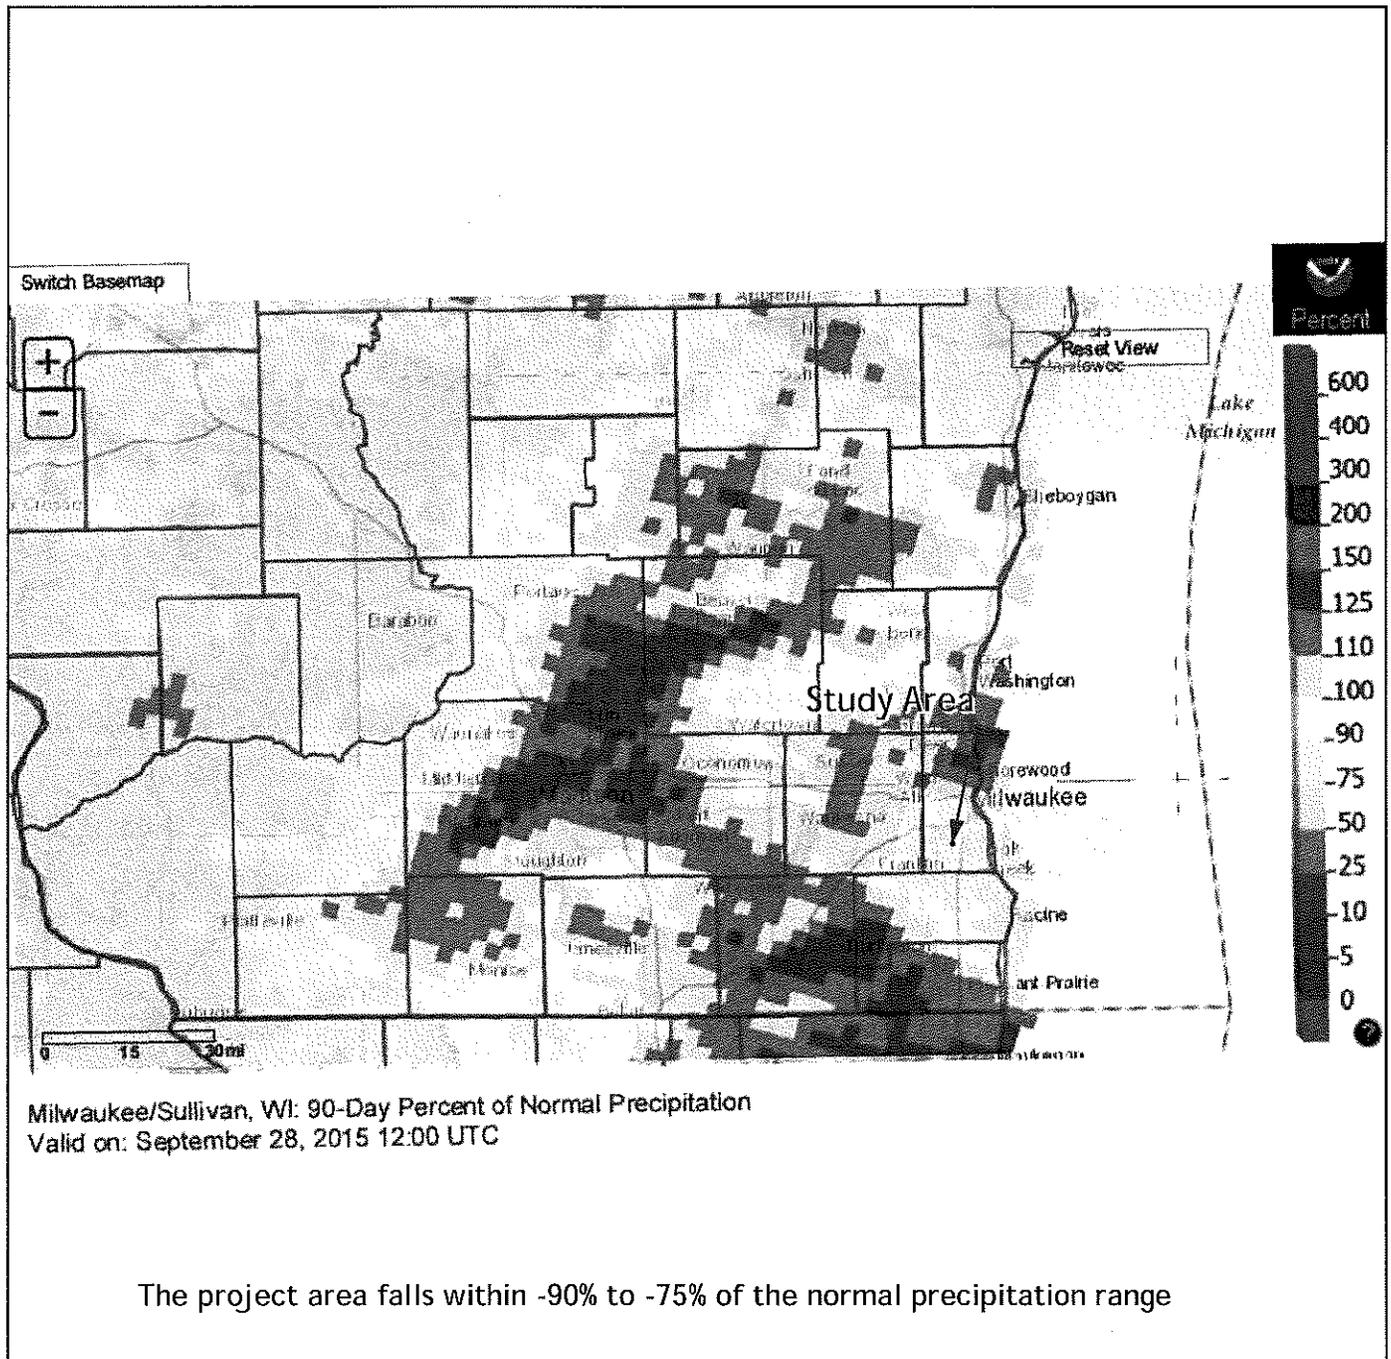
Figure 5
90-Day Percent of
Normal Precipitation Map
Approx. 10-Acre Study Area
Located at 6803 S. 27th Street
City of Franklin
Milwaukee County, WI

Based on the WETS Analysis Worksheet in Appendix 2, precipitation was within the normal range for the months of July through September. Additionally, NOAA's Advanced Hydrologic Prediction Service Map (Figure 5) which analyzes precipitation data exactly 90 days prior to the date of the site visit indicates that climatic conditions were considered to be within 75-90% of normal precipitation which on the drier end of the normal range. According to the Daily Precipitation Table in Appendix 2, there was no precipitation recorded one week prior to the September 28th site visit, although there was 2.33 inches recorded two weeks prior to the site visit.

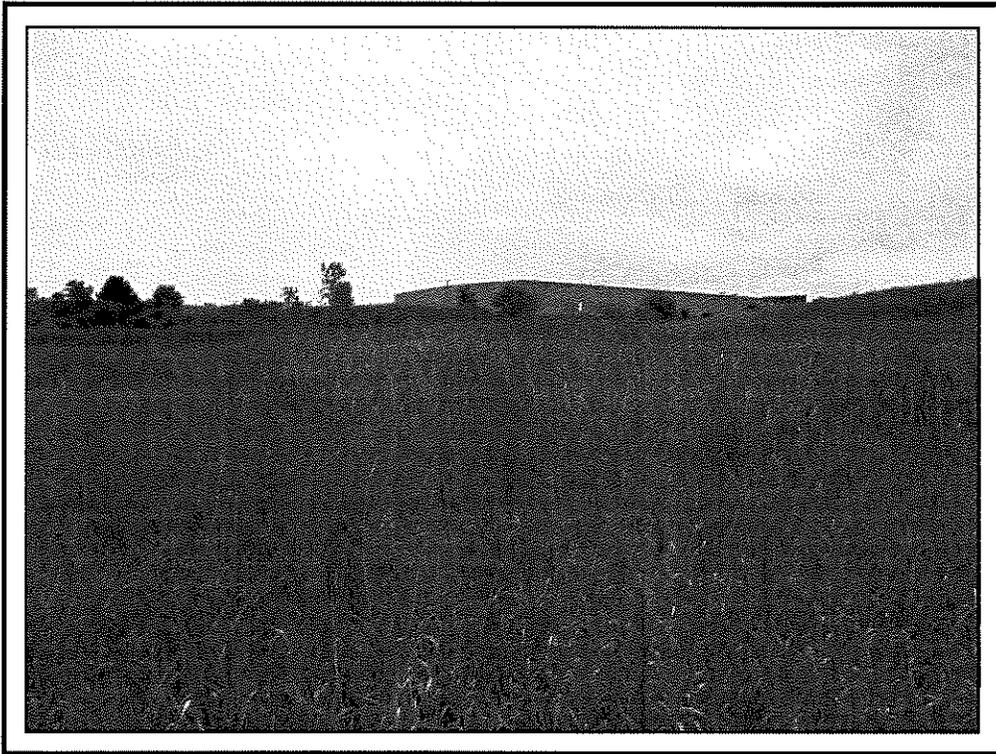
Photograph 1 (9/28/15): Northfacing view of W-1 which contains fresh (wet) meadow and shallow marsh plant communities.

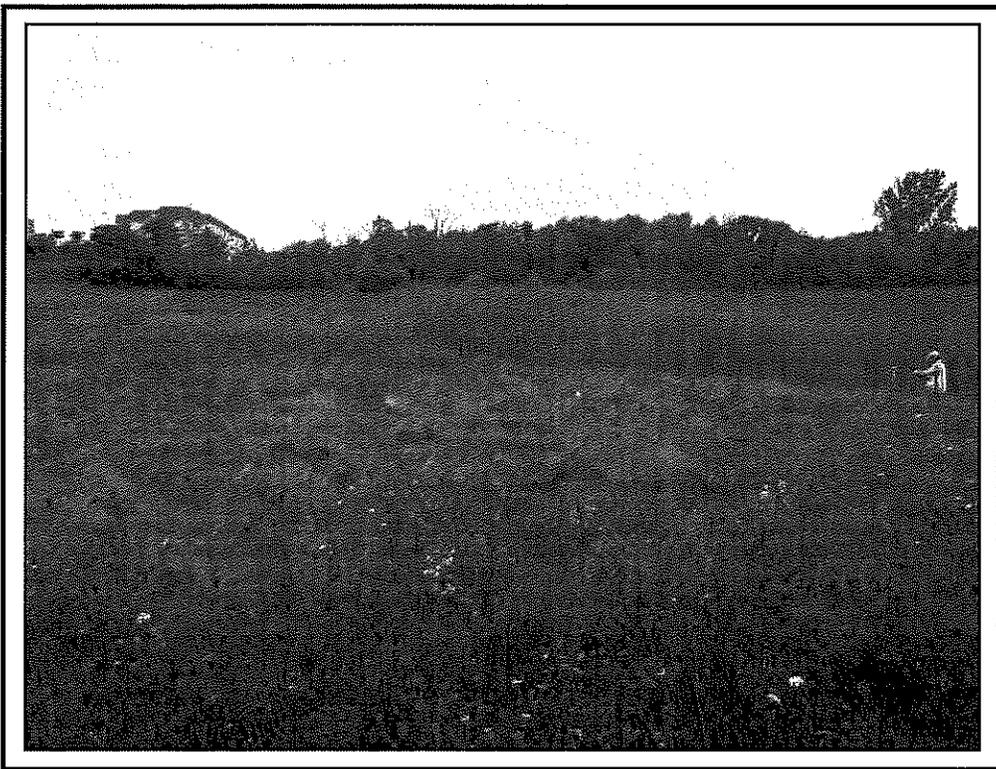
Photograph 2 (9/28/15): Southwest facing view of W-2 and it's adjacent upland meadow. W-1 is also visible on the far left side of the photo.

As shown on Figure 2 in Appendix 1, W-2 is the largest of the three wetlands and is 4.75-acres within the Study Area. It is shown as being an Emergent wet meadow (E1K) on Figure 5 which is consistent with the shallow marsh and fresh (wet) meadow plant communities observed by RASN. The mapped WWI wetland is fairly consistent with the size and location of W-2, except that it does not include one of the two ditches as observed and delineated by RASN. This wetland is directly connected with a ditched waterway about 8 to 10 feet wide that flows south along the far western end of the Study Area. This waterway originates from Mud Lake to the northwest of the site and ultimately connects with the Root River. The wetland is dominated by primarily by giant reed grass and narrow-leaved cattail and is bordered by the same low quality upland meadow that surrounds W-1. Please refer to the site photos in Appendix 3 for various depictions of W-2 and the adjacent uplands.

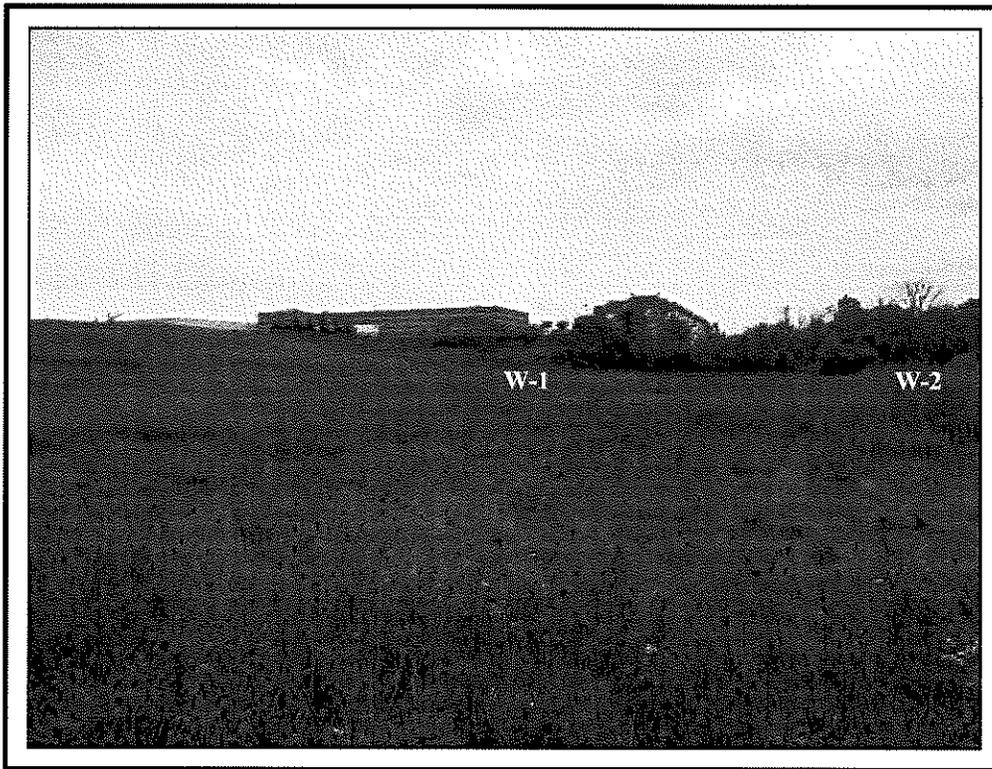
Photograph 3 (9/28/15): South facing view of the site near W-1 and W-2.

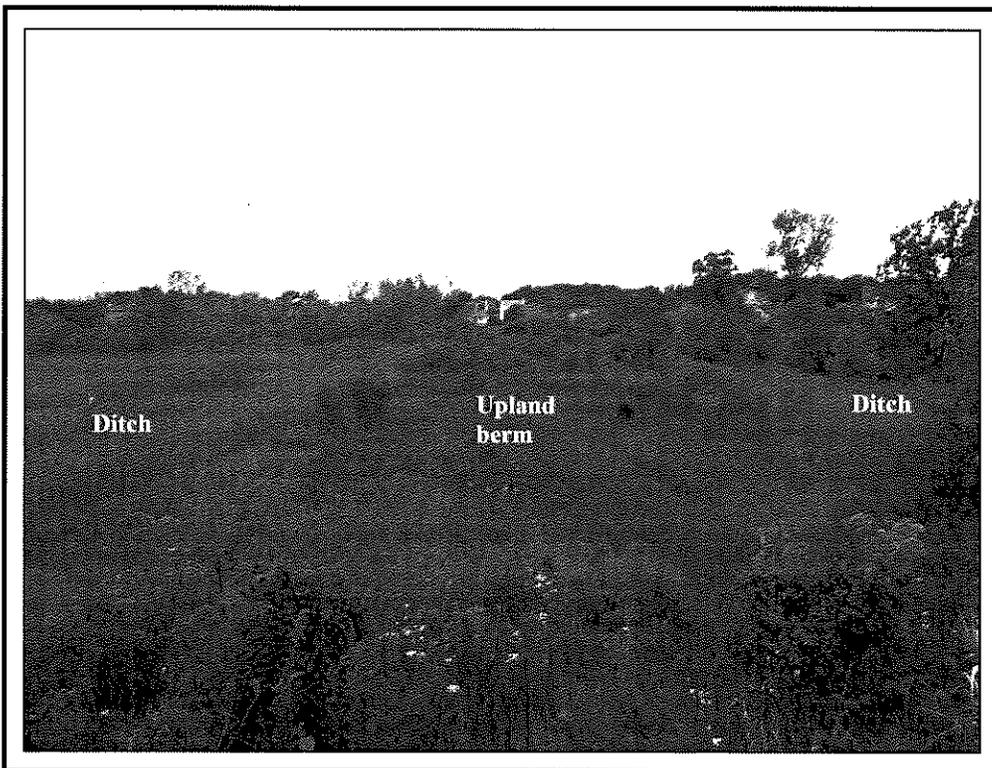
Photograph 4 (9/28/15): West facing view of the two wetland ditches that are associated with W-2, as well as the upland berm between them.

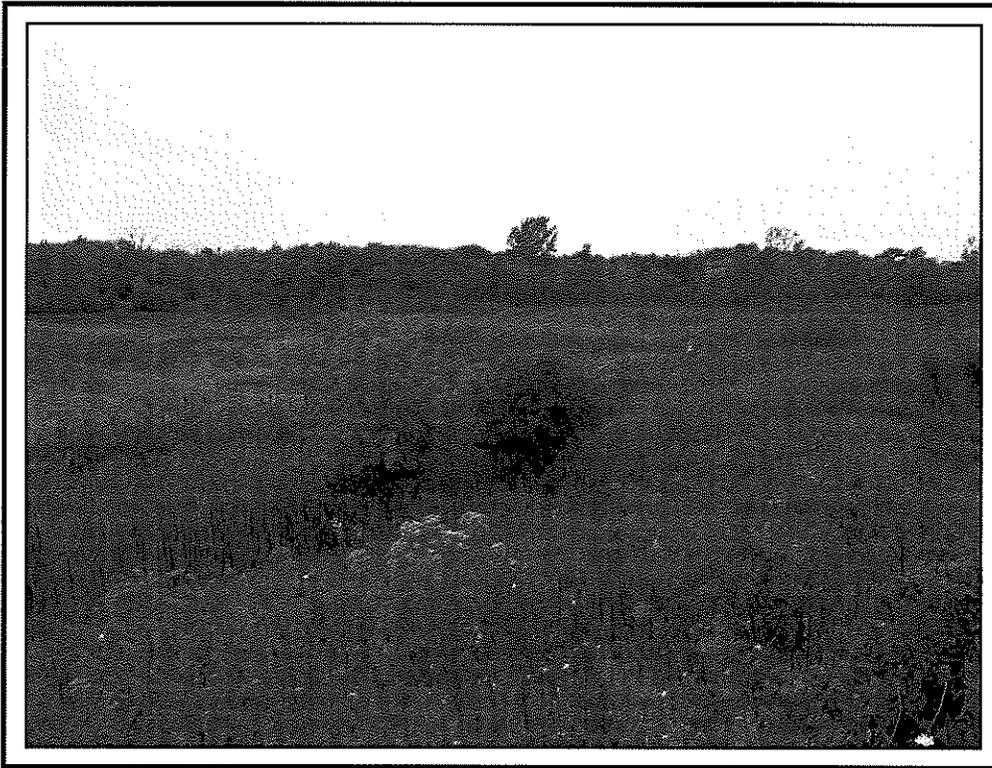
Photograph 5 (9/28/15): General southwest facing overview of the southern portion of the site.

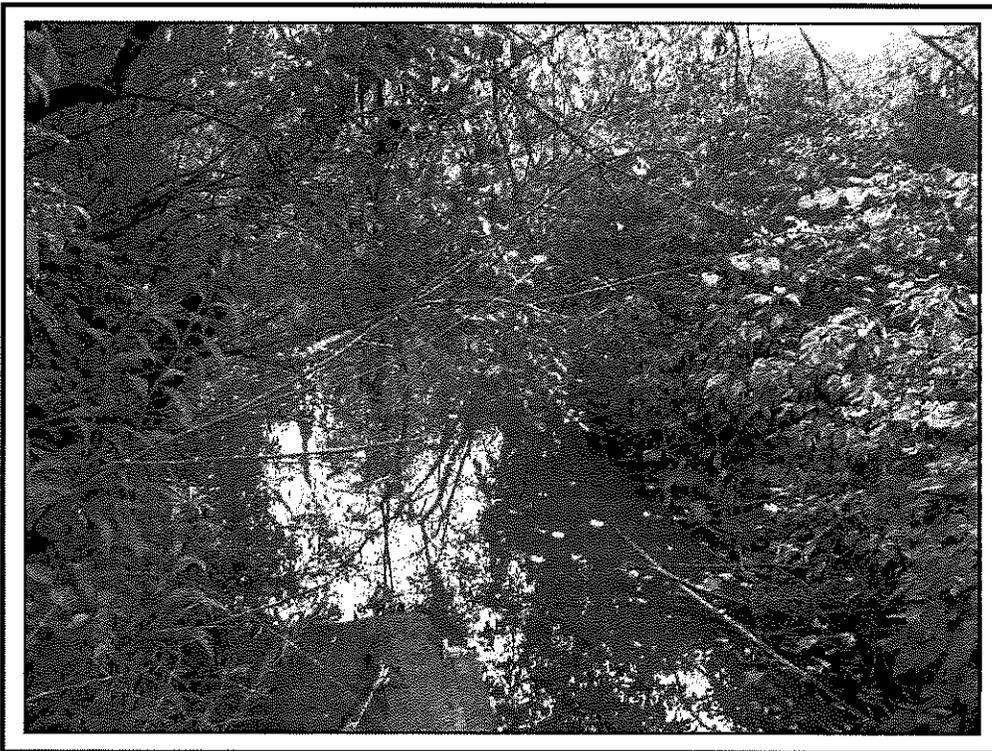
Photograph 6 (9/28/15): South facing view of the waterway that traverses south along the western boundary of the site.

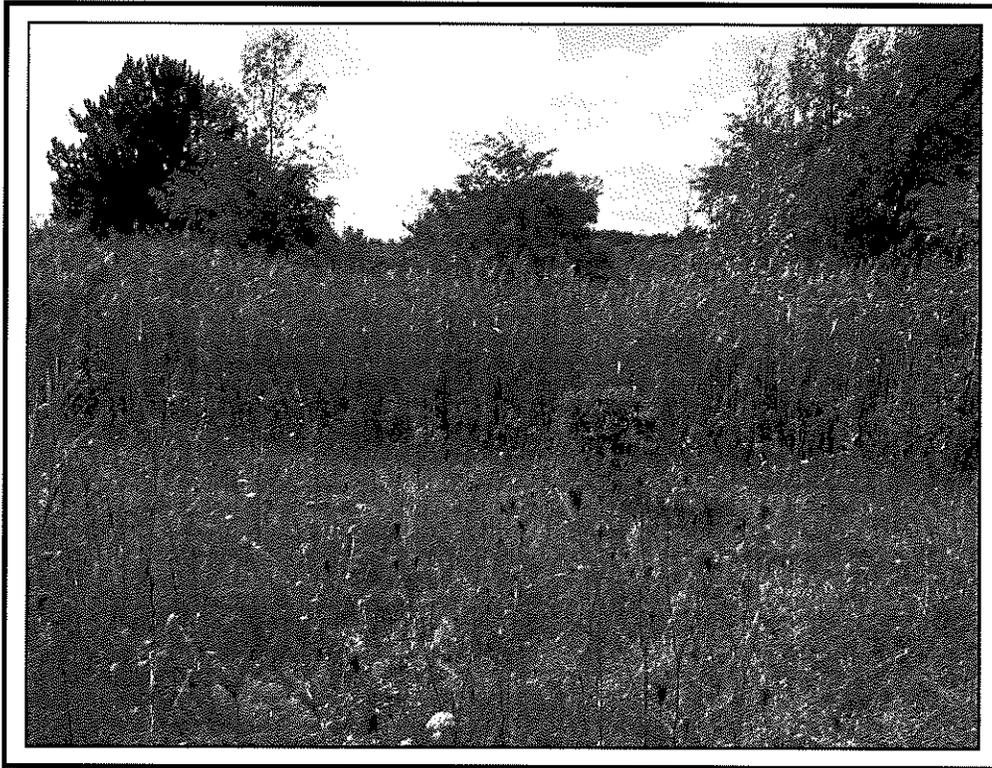
Photograph 7 (9/28/15): West facing view of W-3, a degraded fresh wet meadow dominated by giant reed grass (*Phragmites australis*). Upland data point DP-12 is visible in the foreground.

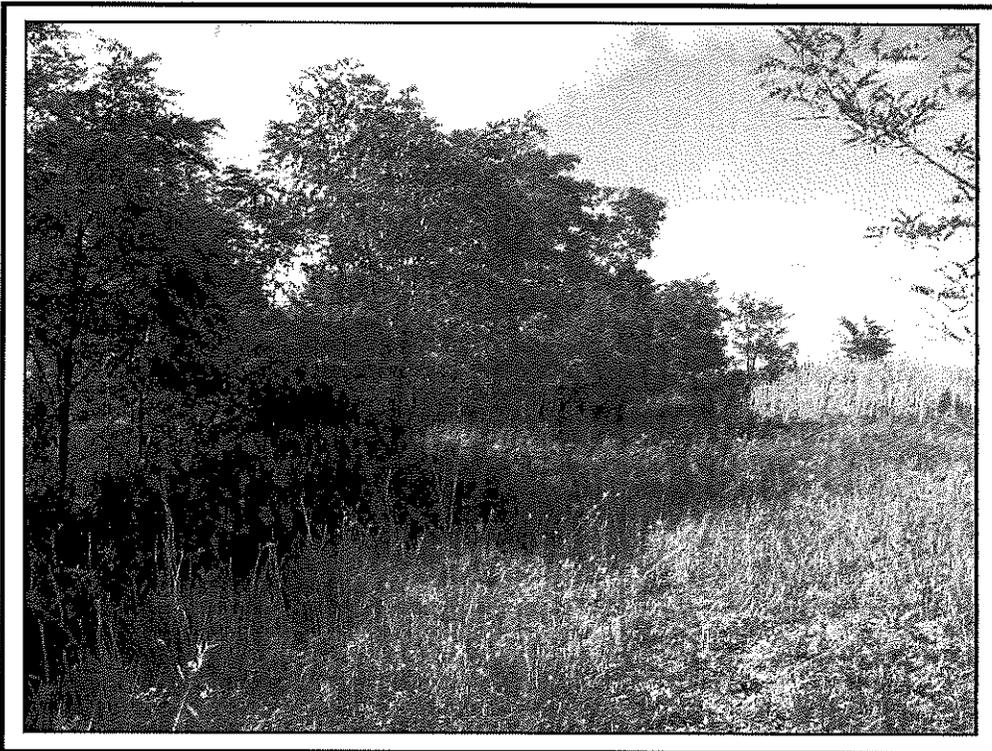
Photograph 8 (9/28/15): General north facing view of the uplands on the north side of the site which were dominated by mostly invasive and weedy species.
