REPORT TO THE PLAN COMMISSION

Meeting of February 5, 2015

Comprehensive Master Plan Amendment, Special Use and Natural Resource Special Exception

Project Name: Autumn Leaves CBRF

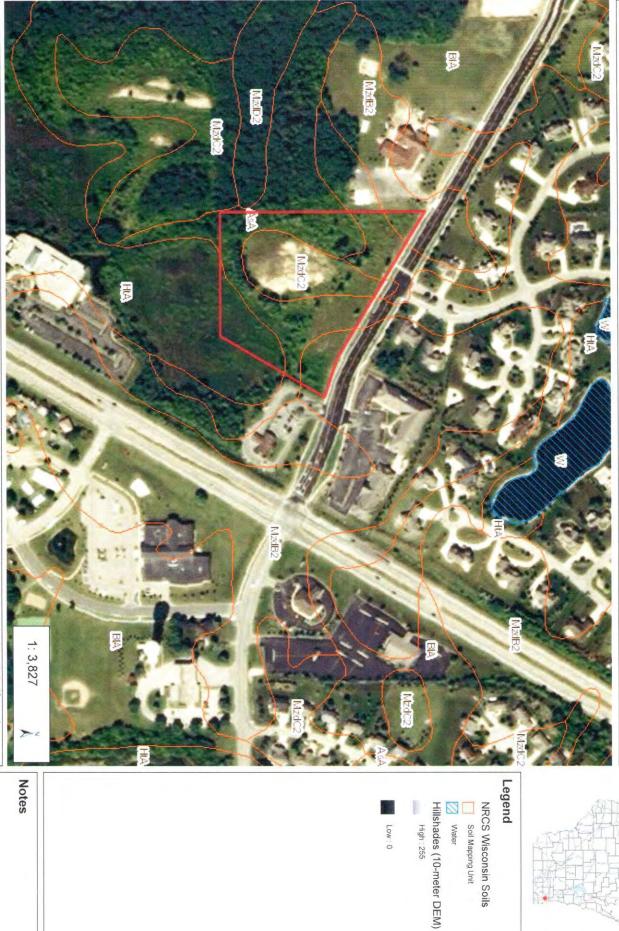
Surface Water Data Viewer Map

Water Soil Mapping Unit

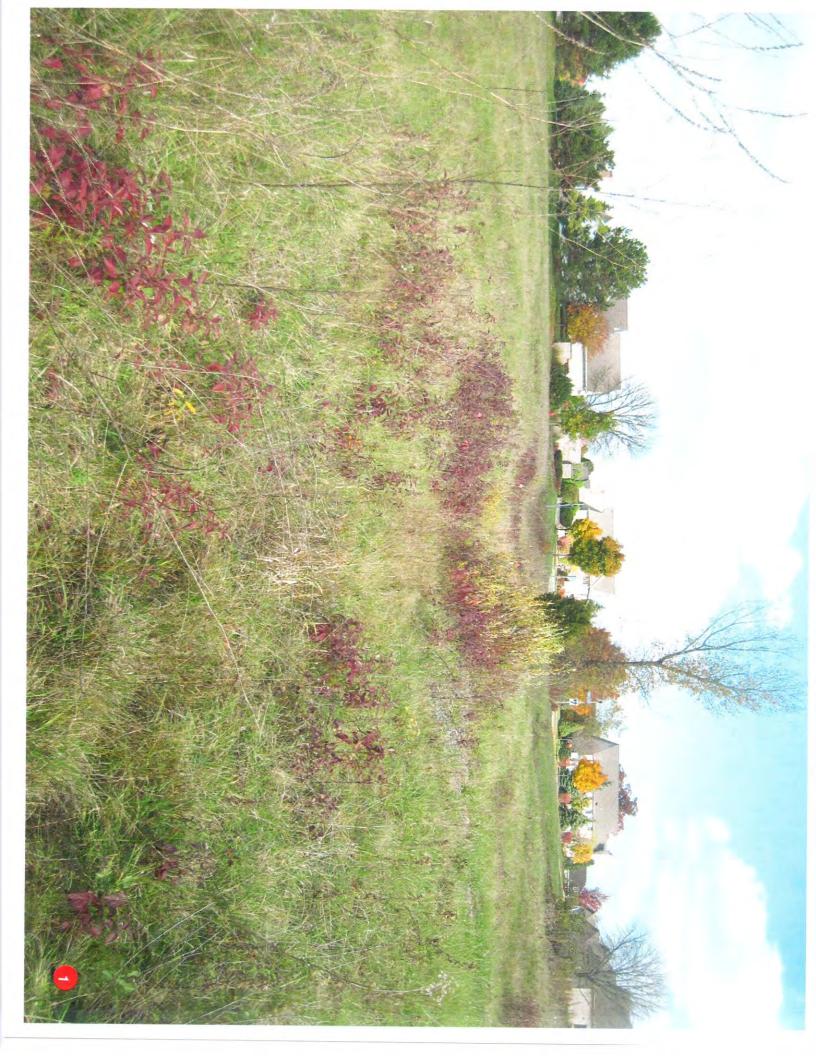
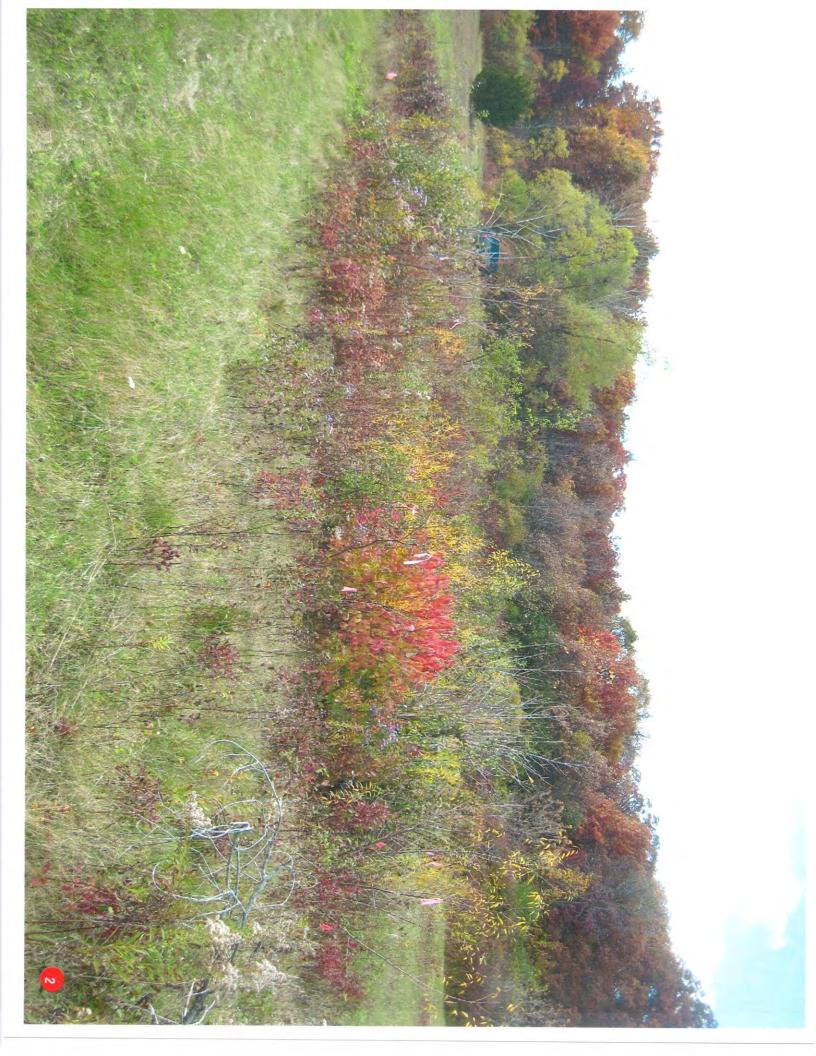
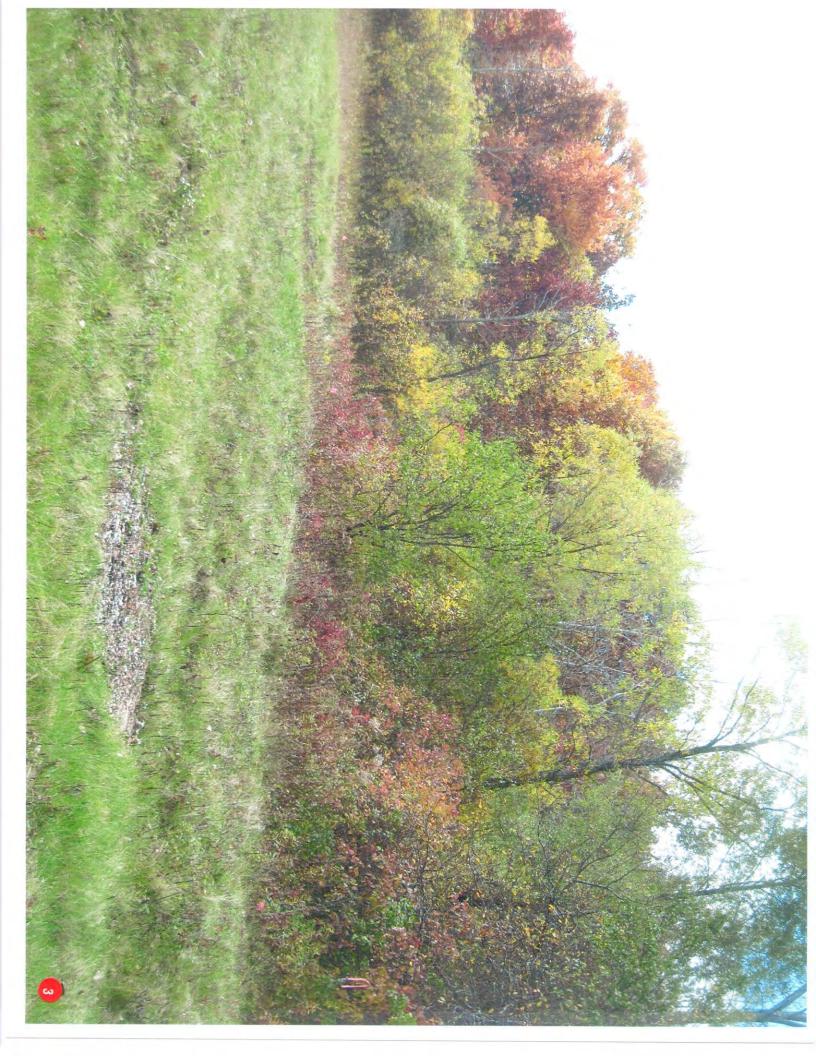
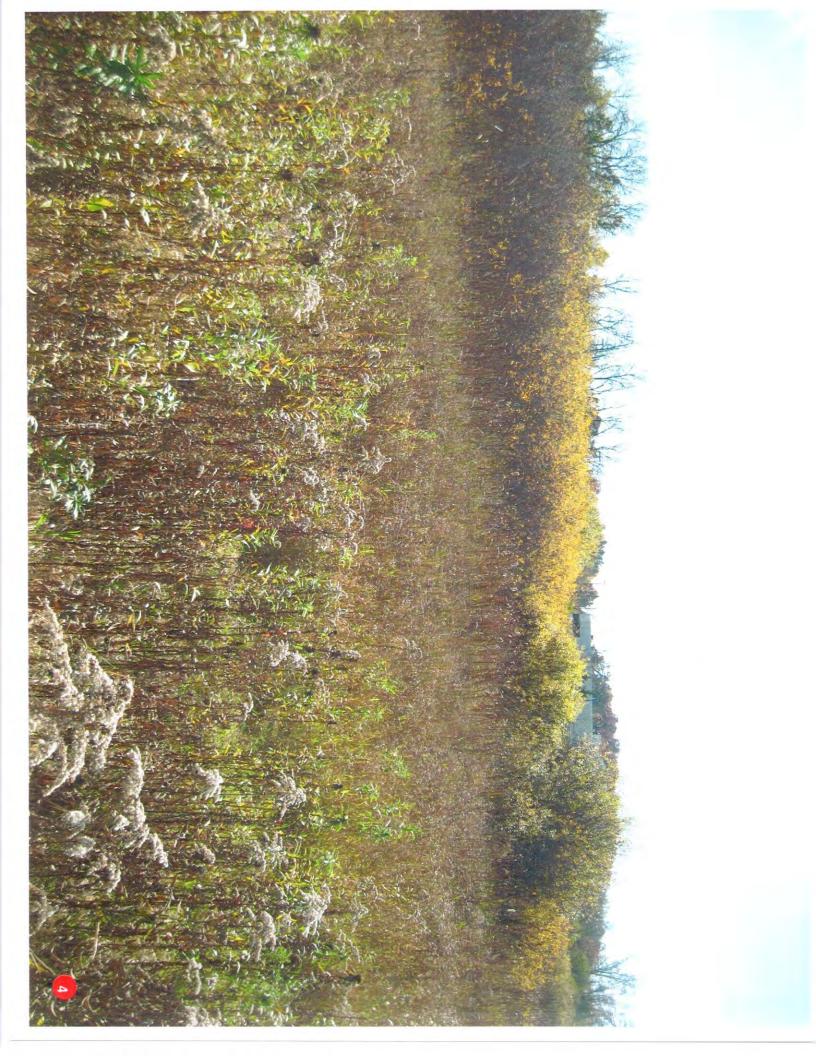
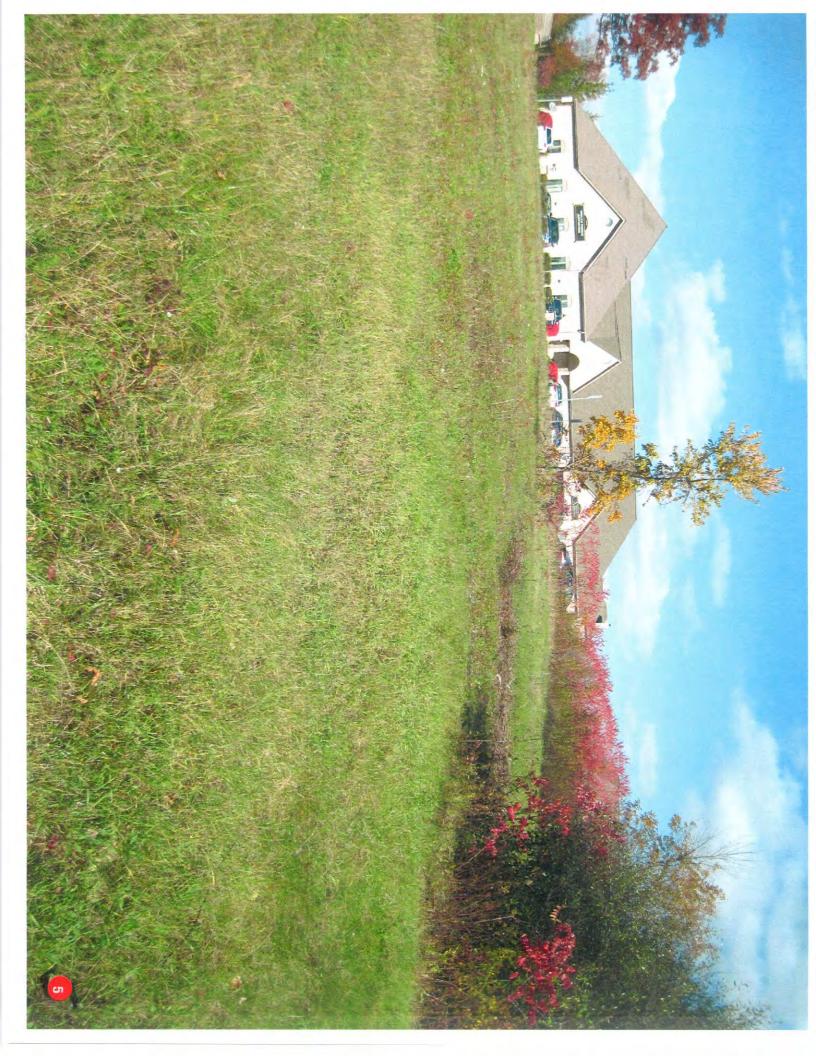
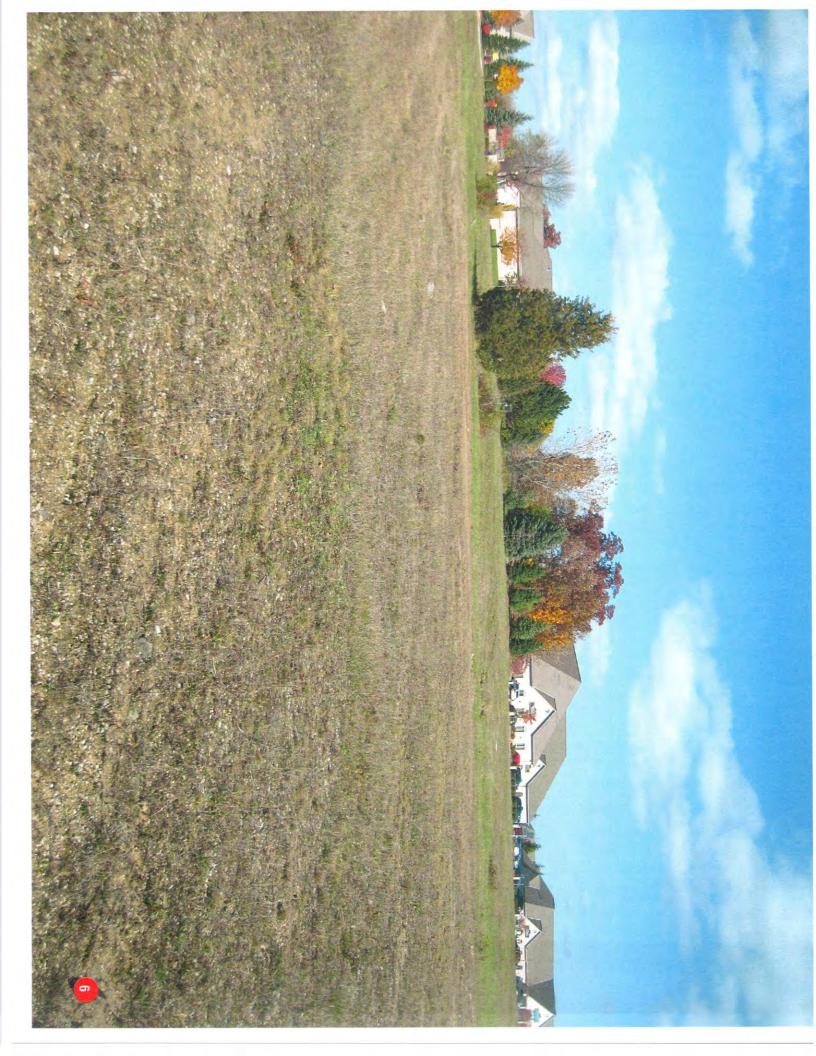
Site Photos

- 1. View looking north through narrow wetland ditch on the west side of the site.
- 2. View looking south across isolated wetland pocket.
- 3. Standing in upland looking southwest toward flagged lowland hardwood forested area.
- 4. View looking south across sedge meadow/shrub-carr.
- 5. Standing on southeast corner of site looking north across upland area.
- 6. Standing in west-central portion of site looking across upland area.
